FINAL REPORT (FINAL DRAFT VERSION)

**Comprehensive Architectural Survey of
Downtown Boone, North Carolina**

Dr. Eric W. Plaag

December 2019

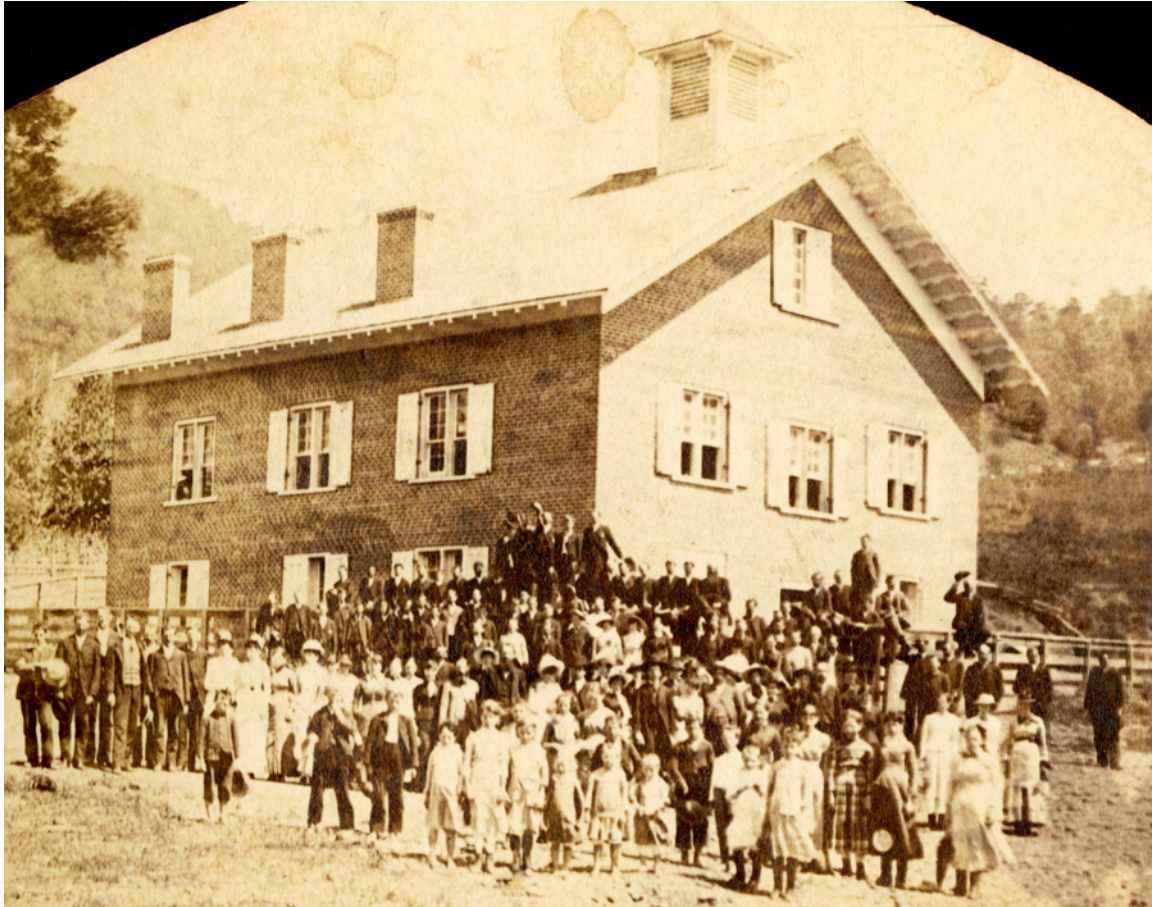
The 1875 Watauga County Courthouse as it appeared about 1885, with what must have been most of Boone's residents standing in front. Image from stereographic card by L. A. Ramsour, courtesy of the Historic Boone Collection, Digital Watauga Project.

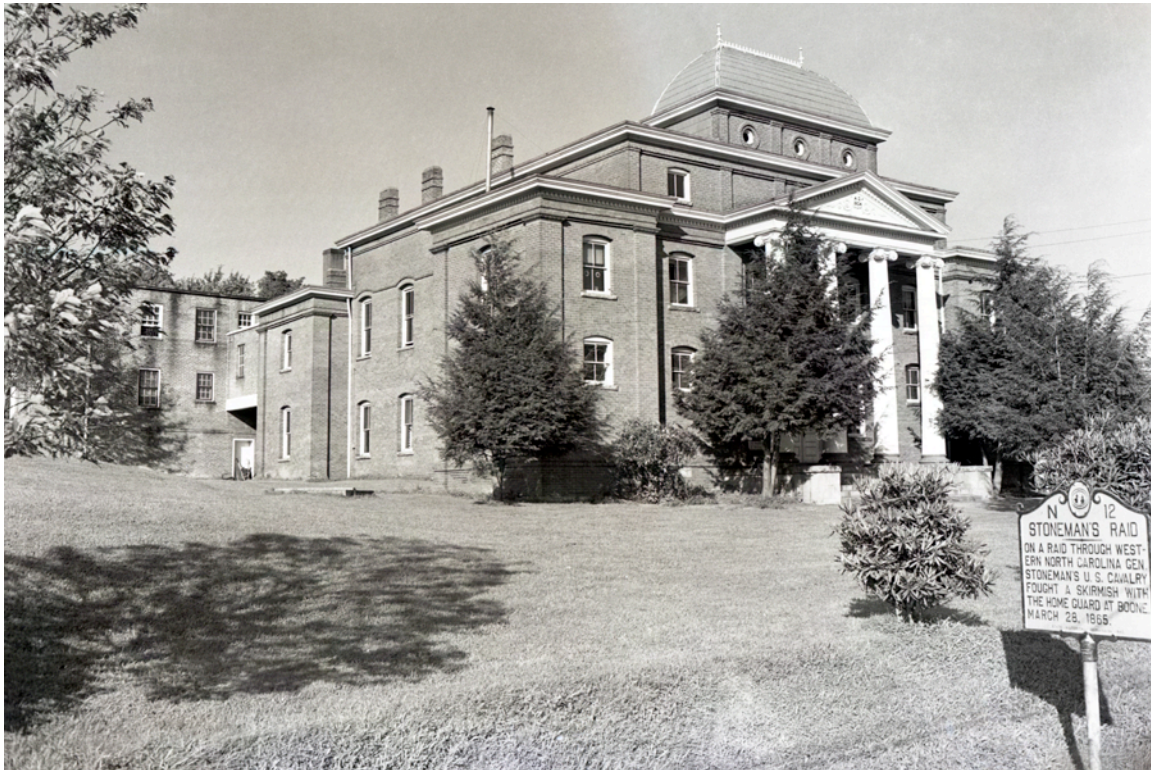
The 1905 Watauga County Courthouse (with the 1927 jail at rear) as they appeared in the 1950s. Image courtesy of the Palmer Blair Collection, Digital Watauga Project.

After decades of complaints about soft brick, shifting foundations, and a lack of repairs, county officials demolished the 1905 Courthouse in 1967 to make way for the current iteration.

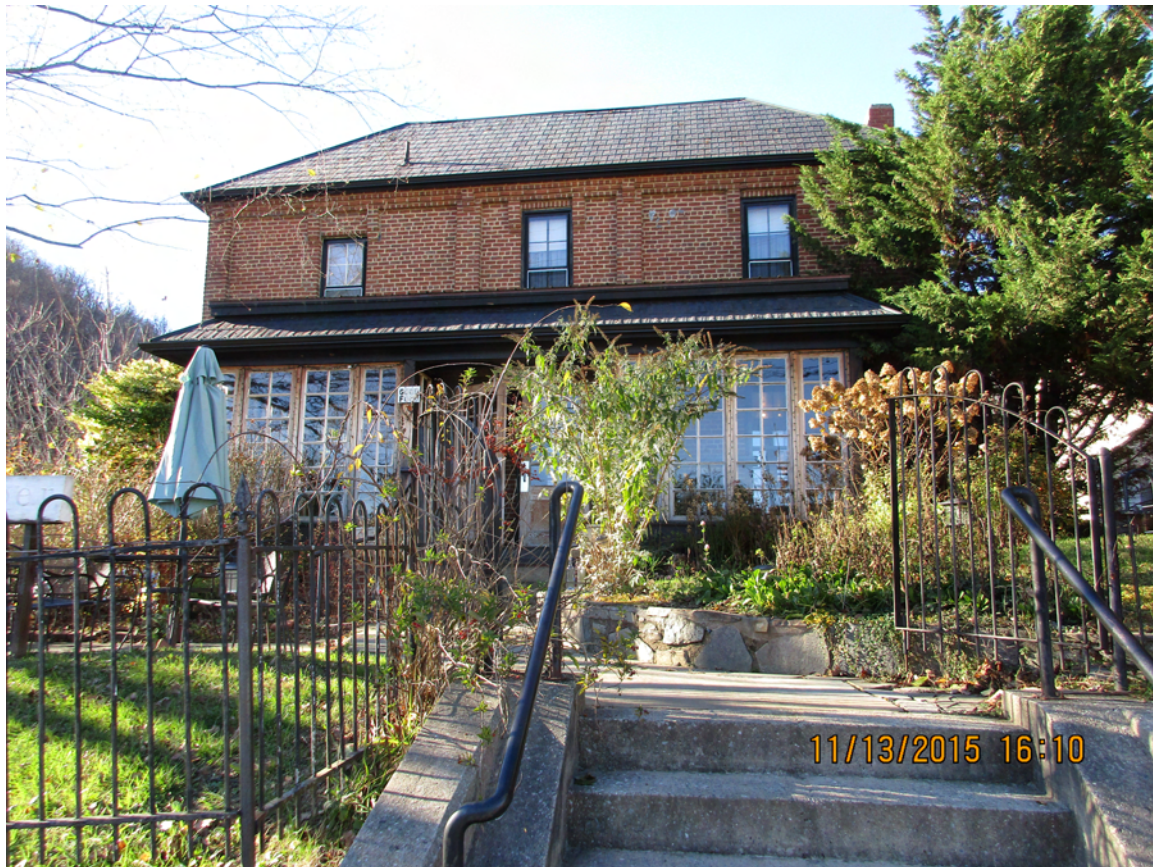
The 1889 Watauga County Jail (WT0067) as it appeared in November 2015. Image by Nicole Holladay.

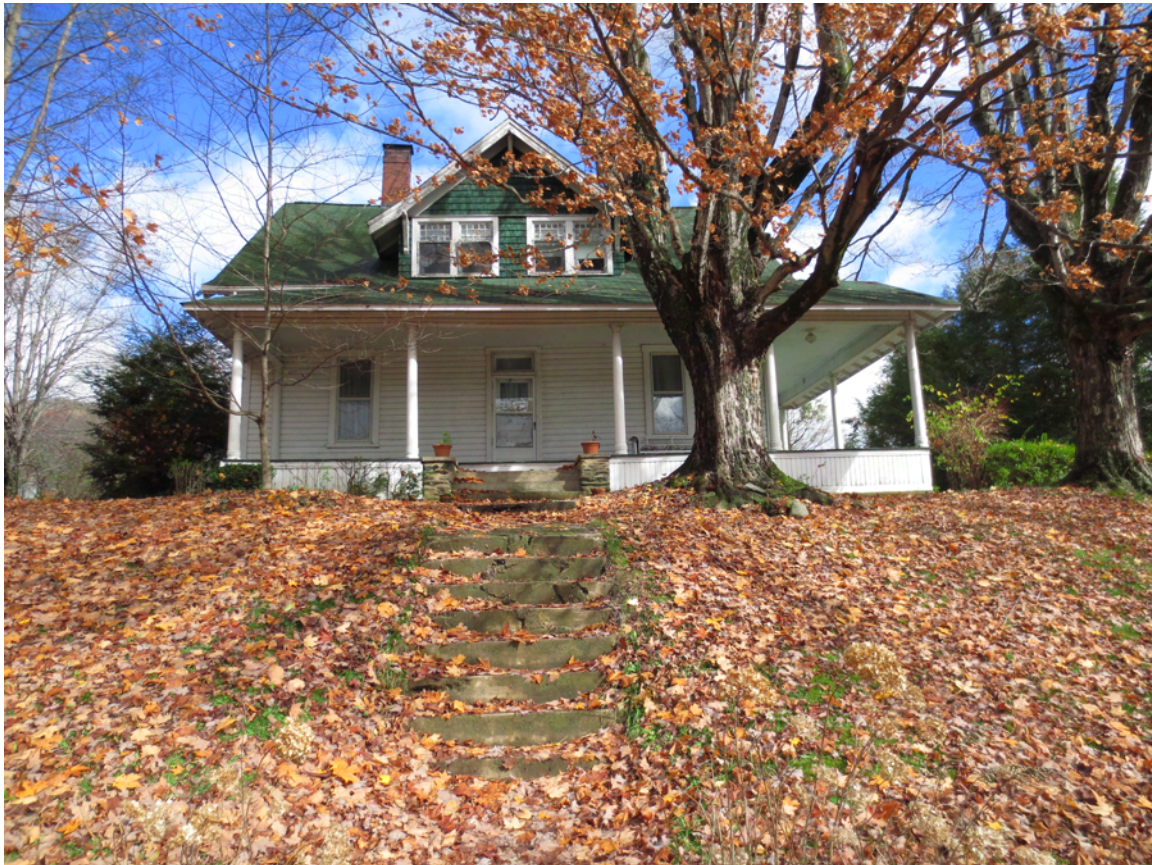
The Frank A. Linney House (WT0582) as it appeared in 2015. Image by Eric Plaag.

Just east of the Moretz house is an even older residential structure, the Frank A. Linney House (WT0582). Like the Moretz House, the Linney House started out as a substantially smaller, one and a half-story, four-bay, front-gabled, wood-frame residence facing Queen Street with a one and a half-story L, perhaps with a south-facing dormer. R. L. Council (1864-1895) built this smaller version of the house in 1894. Linney purchased the house in 1902 and substantially altered the house in 1915, adding two rooms to the redirected front (King Street side) of the house as well as a center hall and a dramatically expanded second floor. At this time, contractors E. G. Farthing and Joe C. Hodges also incorporated numerous Craftsman

and Queen Anne elements into the house, creating its current appearance. The house was designated as a Local Historic Landmark in 2017.

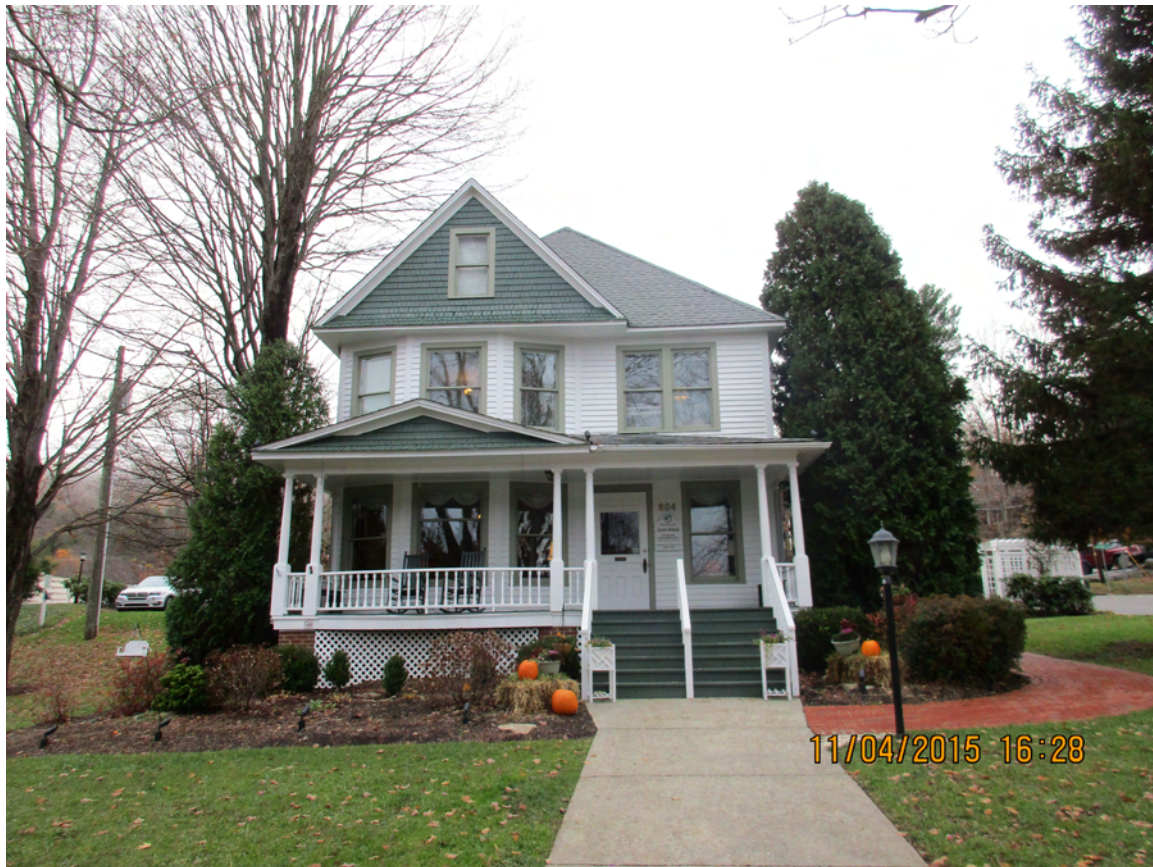
The J. Walter Jones House (WT0008) as it appeared in November 2015. Image by Eric Plaag.

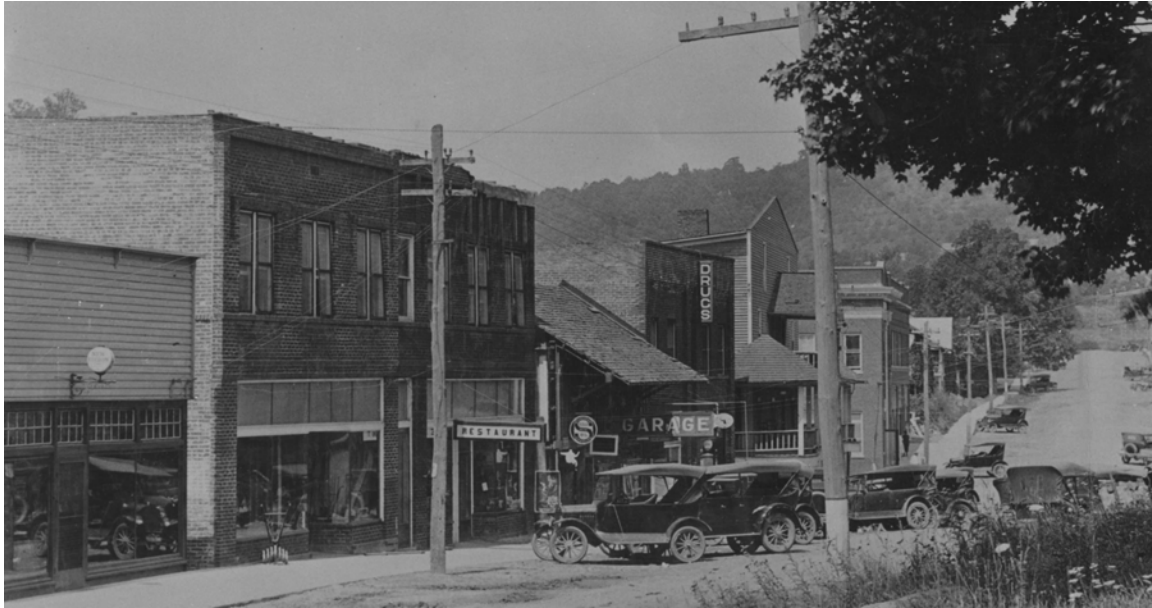
Seen here is the south side of King Street east of Depot Street as it appeared in 1923, with a mix of old construction and the new brick buildings going up as part of the Watch Boone Grow campaign. Left to right are the old Watauga Drug Store, the J. L. Qualls Block, Winkler's Garage in the remnant of the Old Brick Row, the Boone Drug Company Building, and the Critcher Hotel. The Watauga County Bank is also visible on the west side of Depot Street, just right of the telephone pole in the right foreground. Image courtesy of the Historic Boone Collection, Digital Watauga Project.

The following year, 1922, proved to be the zenith of the Watch Boone Grow campaign. Work began in March on the J. L. Qualls Block (WT0595), which was another two-story, brick, commercial block that was somewhat wider than the Boone Drug Company Building along King Street but otherwise bore a striking similarity in design.⁴⁷ Once Triplett and Poe's workers completed the masonry on the Qualls Block in July, they shifted across the street to began construction of the J. Walter Jones Building (WT0591), which also featured two storefronts flanking a center entrance set off by pilasters.⁴⁸ Meanwhile, the same contractor began work on the Boone Garage (part of which survives at the east end of WT0819).⁴⁹ Both buildings were finished by the end of 1922. Another major construction project that year was the new Boone United Methodist Church (WT0610) located toward the east end of King Street. The rotunda-form auditorium featured a dome, clerestory windows, prominent, dentiled entablature, and fantastic Corinthian columns. The church was completed in August 1923 but destroyed by fire in 1981.⁵⁰

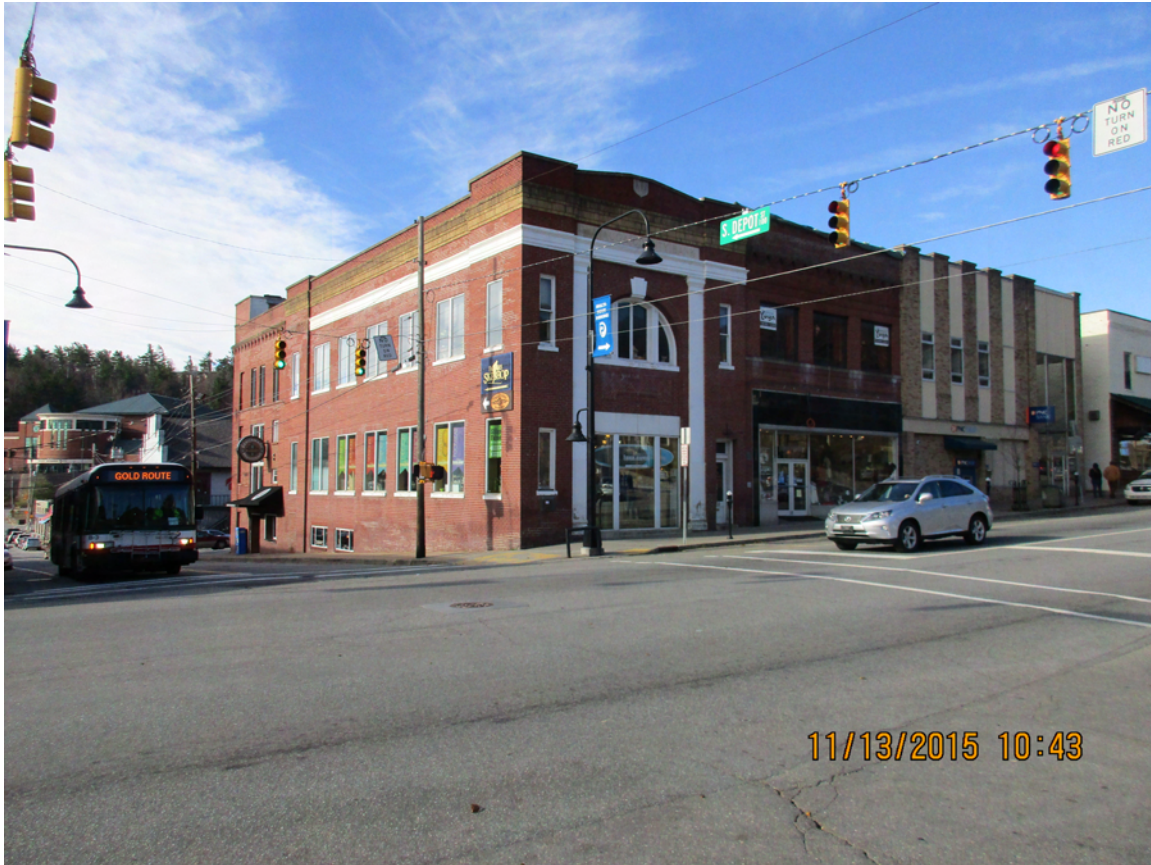
The Watauga County Bank Building (WT0590) and the Boone Hardware/Farmer's Hardware Block (WT0589) as they appeared in November 2015. The west portion of the Farmer's Hardware Block was dramatically rehabilitated in 2019. Image by Paul Fuller.

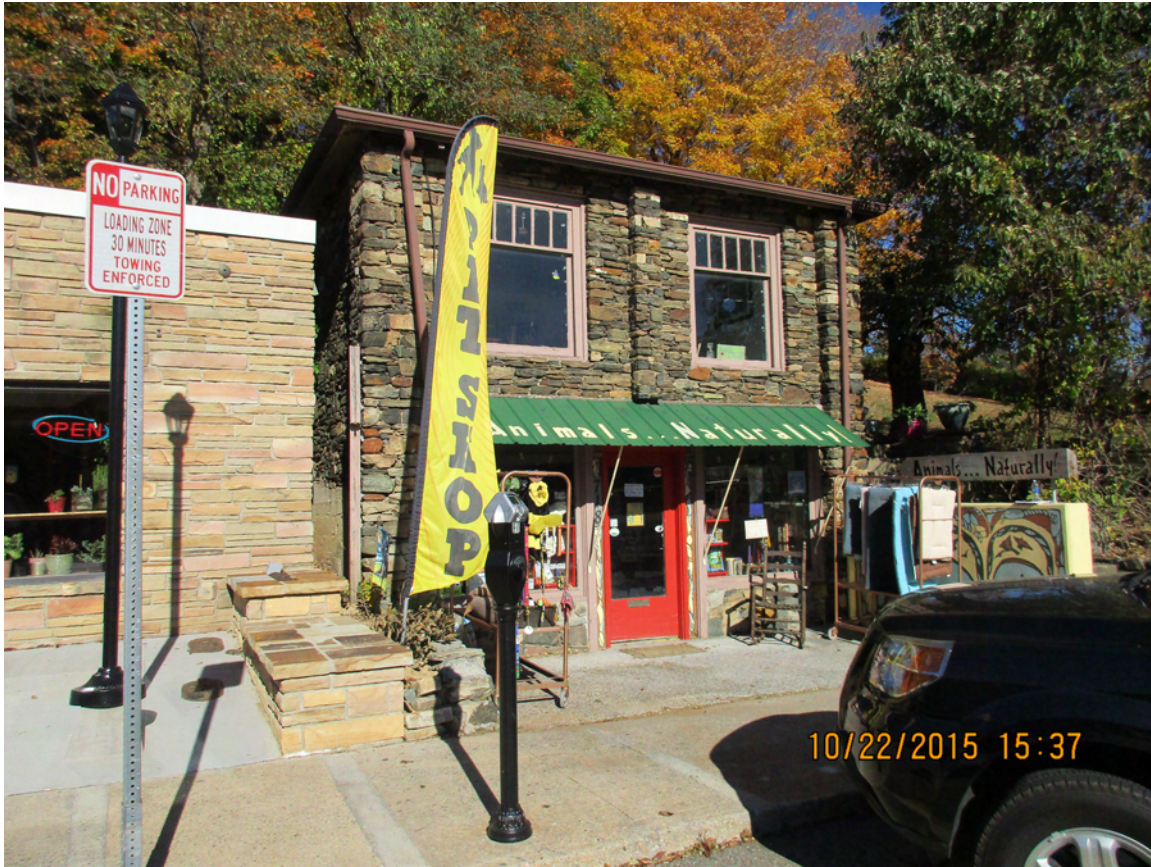
The Linney Law Office (WT0587) as it appeared in October 2015. Image by Eric Plaag.

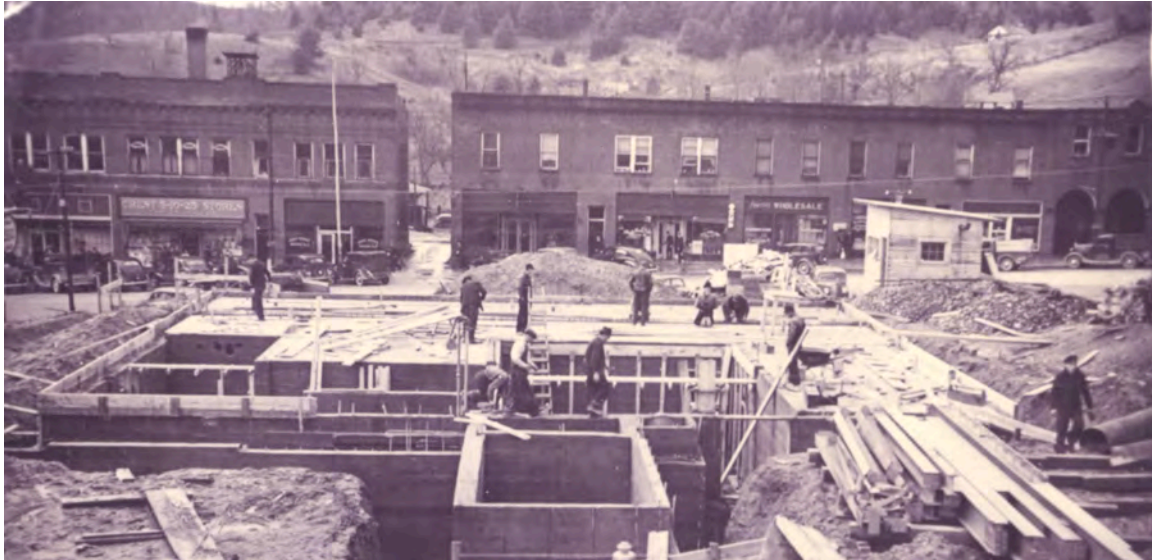
Seen here are workers constructing the US Post Office in 1938. Left to right across King Street are the Farmer's Hardware Block, the Frank A. Linney Block, and part of the Pastime Theatre. Image courtesy of the Historic Boone Collection, Digital Watauga Project.

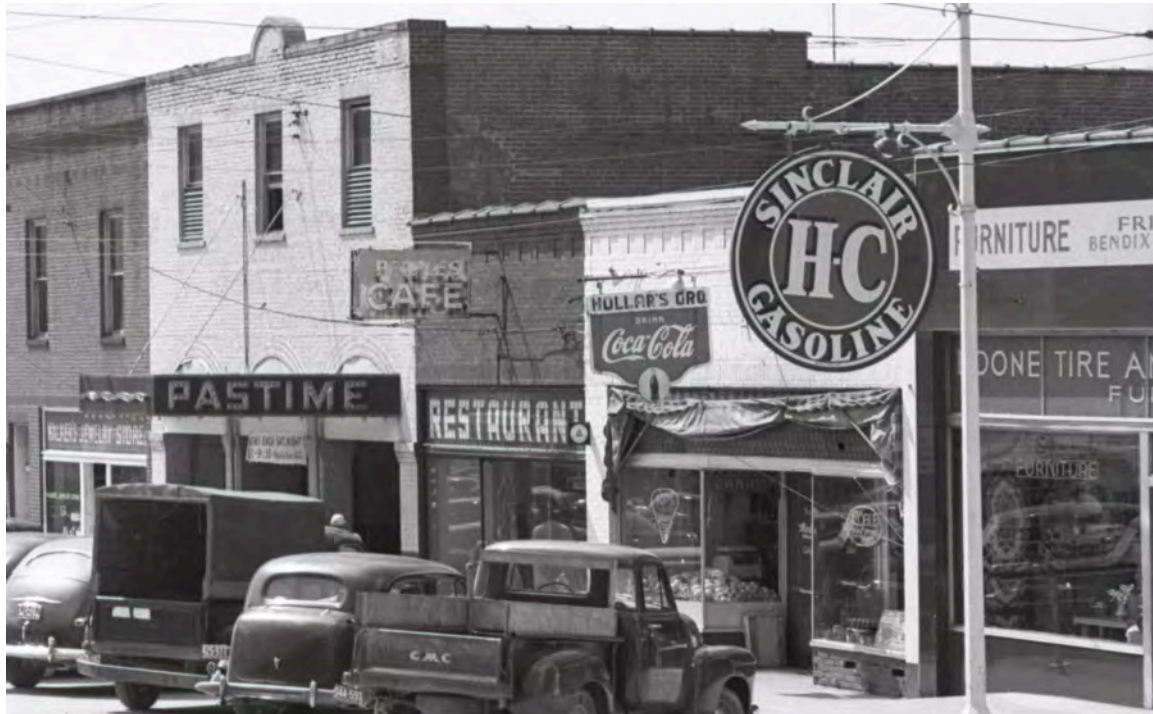
The Pastime Theatre at left, as seen in 1952, added a marquee sometime after 1940. The Boone Electric Company Building and the W. S. Goodnight Building are visible to the right of the Pastime. Image courtesy of the Palmer Blair Collection, Digital Watauga Project.

Also built in 1924 was the Pastime Theatre (WT0858), located at the west end of the Linney Block but technically built as a distinct property. The creation of W. R. Winkler (1900-1997) and A. E. Hamby (1889-1945), who had long shown movies in the 1905 Courthouse, the Pastime occupied Boone's first purpose-dedicated theater building and operated until 1959. Its brick, King Street exterior offered an architectural element not otherwise found in Boone's boom-period buildings—rounded arches. These three arched openings, framed by triple-tier, rowlock arches set on corbel-collared, brick impost columns, were positioned at the two-story building's street level and led to what was essentially a deep, open-air arcade. Sadly, the building was dramatically transformed in 1960 and covered with concrete panels, but recent investigations have determined that the brickwork and the arches themselves still survive beneath the current façade.

Other 1925 buildings included two one-story, commercial block, brick buildings located immediately west of the Pastime Theatre: the Boone Electric Company Building (WT0859) and the W. S. Goodnight Building (WT0860). In a five-year period dominated by construction of large-scale commercial blocks, these buildings introduced some refreshing variety to the streetscape of Boone's building boom. The two buildings, constructed on the site of the old Bryan Cottage, were essentially built in tandem, despite having separate owners.⁵⁸ Both featured nearly identical, recessed entrance storefronts with gorgeous, leaded glass, clerestory windows, triple corbel bands, and a dentil-like band in a pattern of three soldiers to three stretchers in relief. Sadly, the Boone Electric Company Building's original fabric was largely obliterated with the application of crab orchard stone apparently in place of the original brick. In addition, the original clerestory window framing has been replaced by the current aluminum, window wall treatment. There is slightly greater hope that original elements survive underneath the current façade treatment of the W. S. Goodnight Building, which is presently made to appear like something resembling a western saloon.

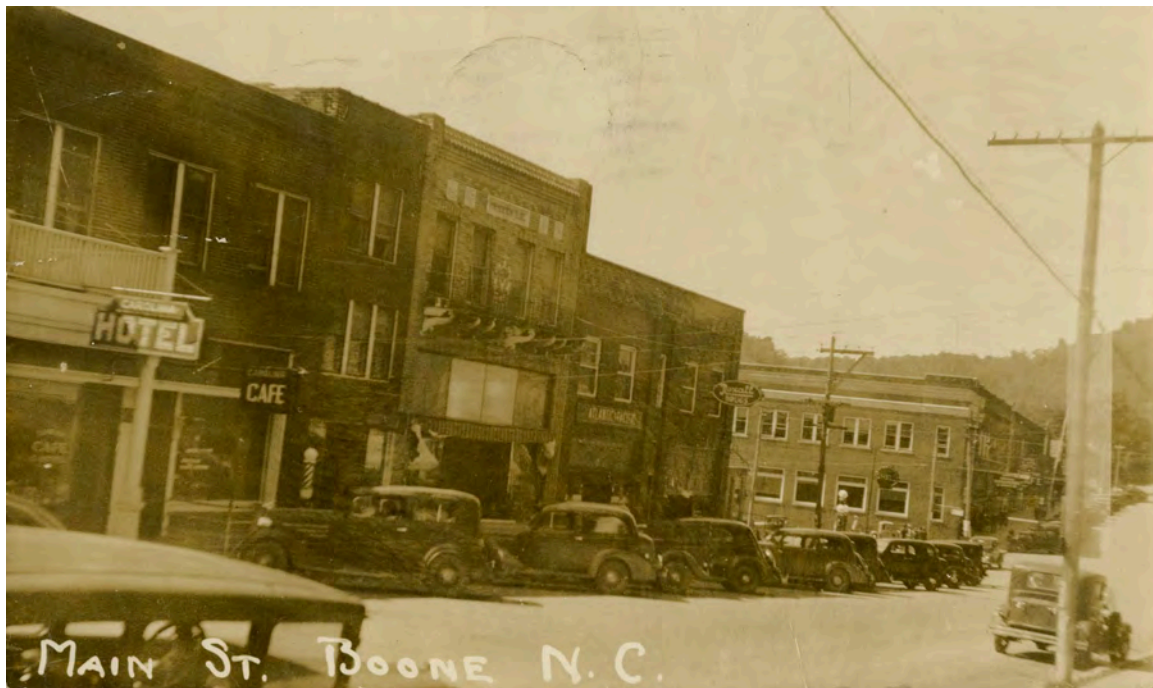
The south side of King Street as it appeared circa 1936-37. Left to right are part of the J. L. Qualls Block (with its porch overhang that stood from 1936 to sometime before 1949), the Perry and Winkler Building, the H. W. Horton Building, the Boone Drug Company Building, a slightly visible portion of the 1936 version of the Shell Service Station (later incorporated into the Crest Five and Ten Cent Store Building), and—across Depot Street—the Watauga County Bank Building.

and built a massive, multi-toned, yellow brick, two-story-with-mezzanine building on the west portion of the site. The H. W. Horton Building's (WT0593) façade was certainly one of the most imposing in Boone to that date (save only for the Watauga County Bank), as it featured a quadruple-tier border of stepped, outer bands of brick and stunted battlements at its upper corners. A truncated shed roof of terracotta tiles sat between the battlements, covering the stepped-back, brick parapet at the top of the elevation. Horton also introduced a prominent limestone frieze plate with his name on it, as well as a large, decorative cartouche just below this. In addition, a large, iron fire escape supported by giant, limestone brackets ran along the front of the building. Most notably, Horton punctuated his design with limestone medallions in the shape of wagon wheels—a trope that appeared frequently in later Boone buildings and was always associated with W. R. Winkler thereafter. The spacious showroom and mezzanine—eighteen feet in total height—were a draw for numerous department stores, five and dimes, and furniture stores in the years that followed. Horton, however, lost the building almost immediately after it was built, as he was unable to pay his contractors.⁶² The building's current owners have recently renovated the Horton Building into a boutique hotel and added a rooftop bar structure in 2018.

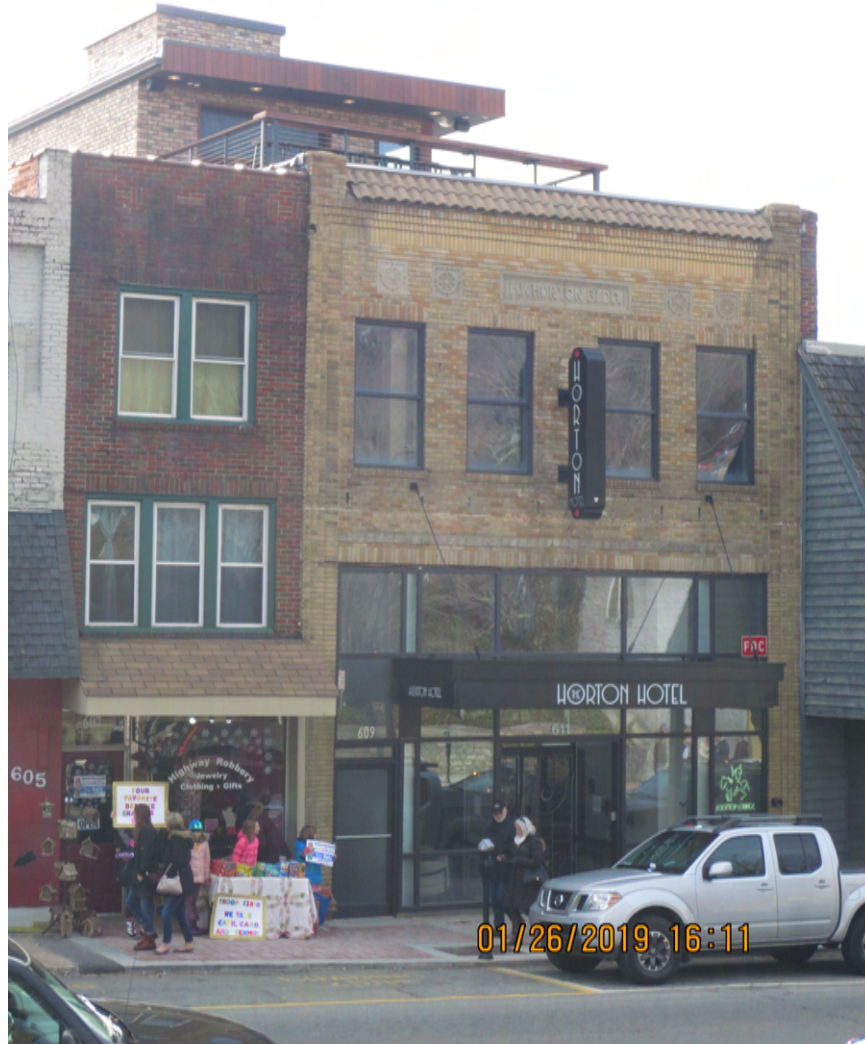
At left is the Perry and Winkler Building (WT0594), with the H. W. Horton Building (WT0593) at right. In 2019, the present owner of the Horton Building completed a massive renovation to convert the building into a boutique hotel with a rooftop bar.

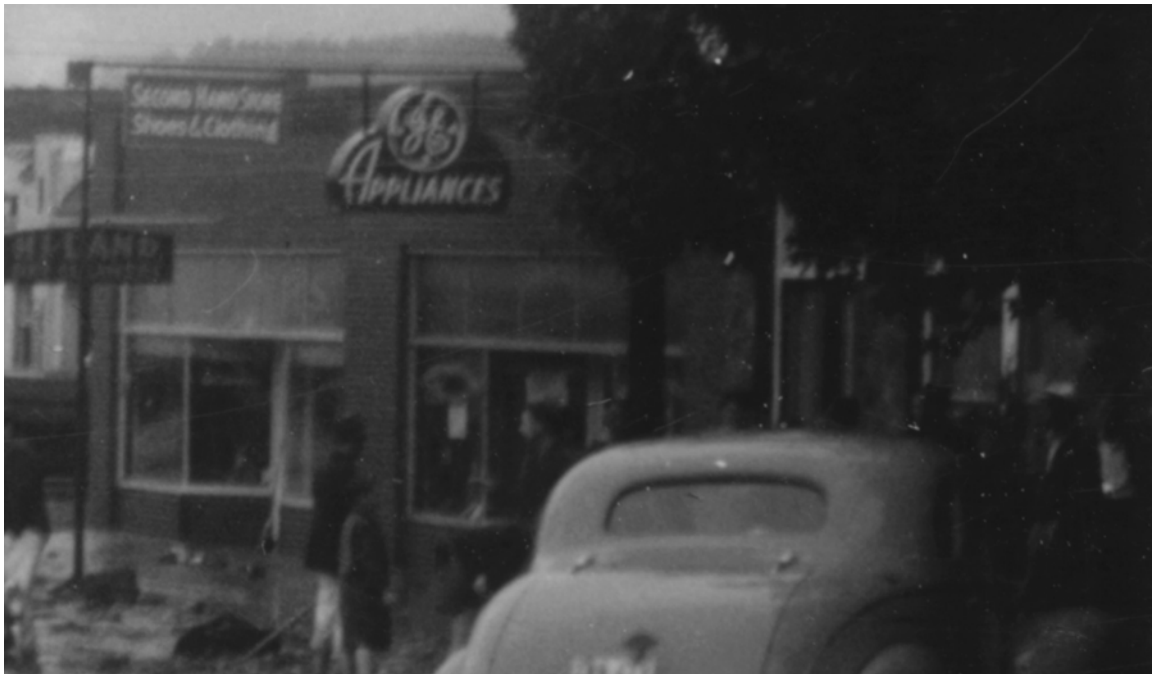
Seen here during the 1940 Flood are the Hi-Land Cleaners Building (left, WT0864) and the C. M. Critcher Building (WT0865) on King Street, built separately but designed to appear as one commercial block. Image courtesy of the David Wyke Collection, Digital Watauga Project.

Other commercial additions in the core downtown area included a tin building located behind the Frank A. Linney Block that was home to Boone's first bowling alley, the Boone Recreation Parlor (WT0869, 1928); the W. R. Winkler Tire Company (WT0894, 1929), located immediately west of the Boone Garage; the one-story, brick Sebastian Building (WT0878, 1931, with additions in 1947 and 1967) at the southwest corner of Water and King, which supplanted the Lovill Law Office; and the twin, one-story, commercial block buildings constructed just east of the *Watauga Democrat* office in 1934—the Hi-Land Cleaners Building (WT0864) and the C. M. Critcher Building (WT0865).

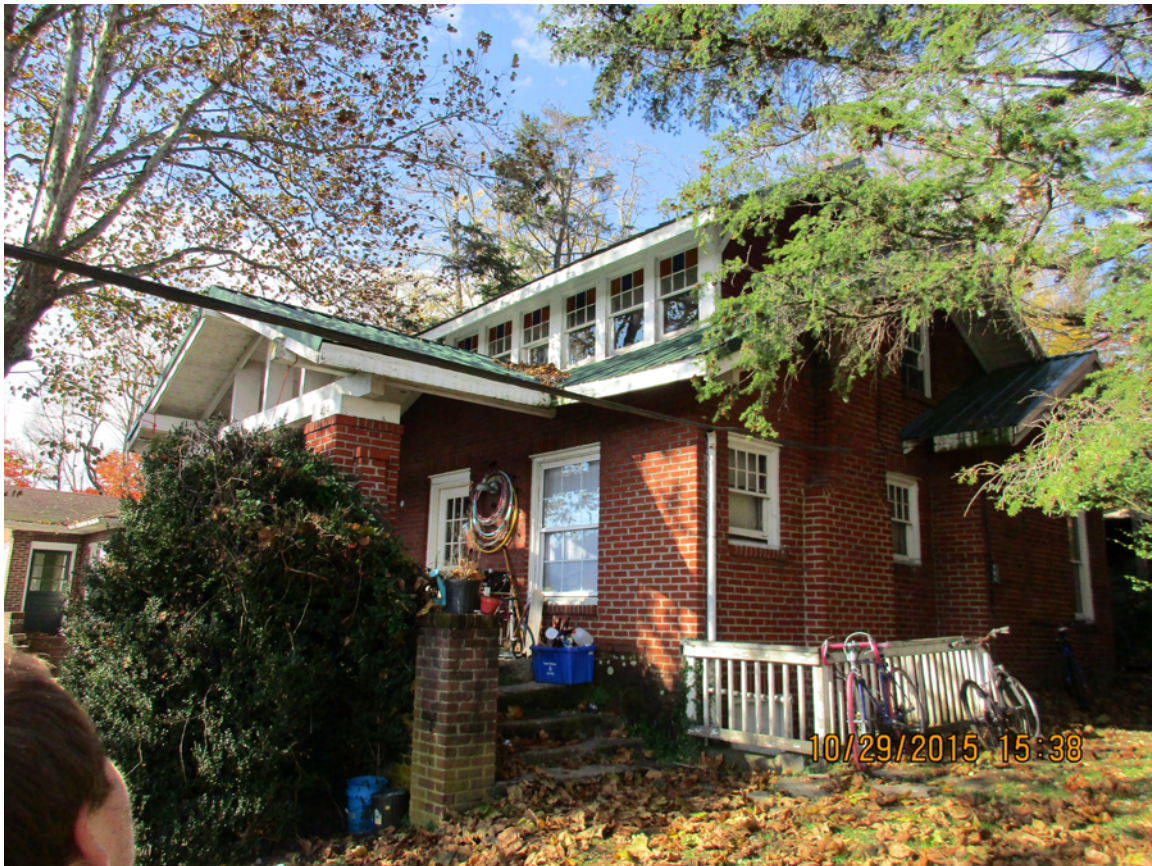
The Chapell Wilson House (WT0580) as it appeared in October 2015. Image by Eric Plaag.

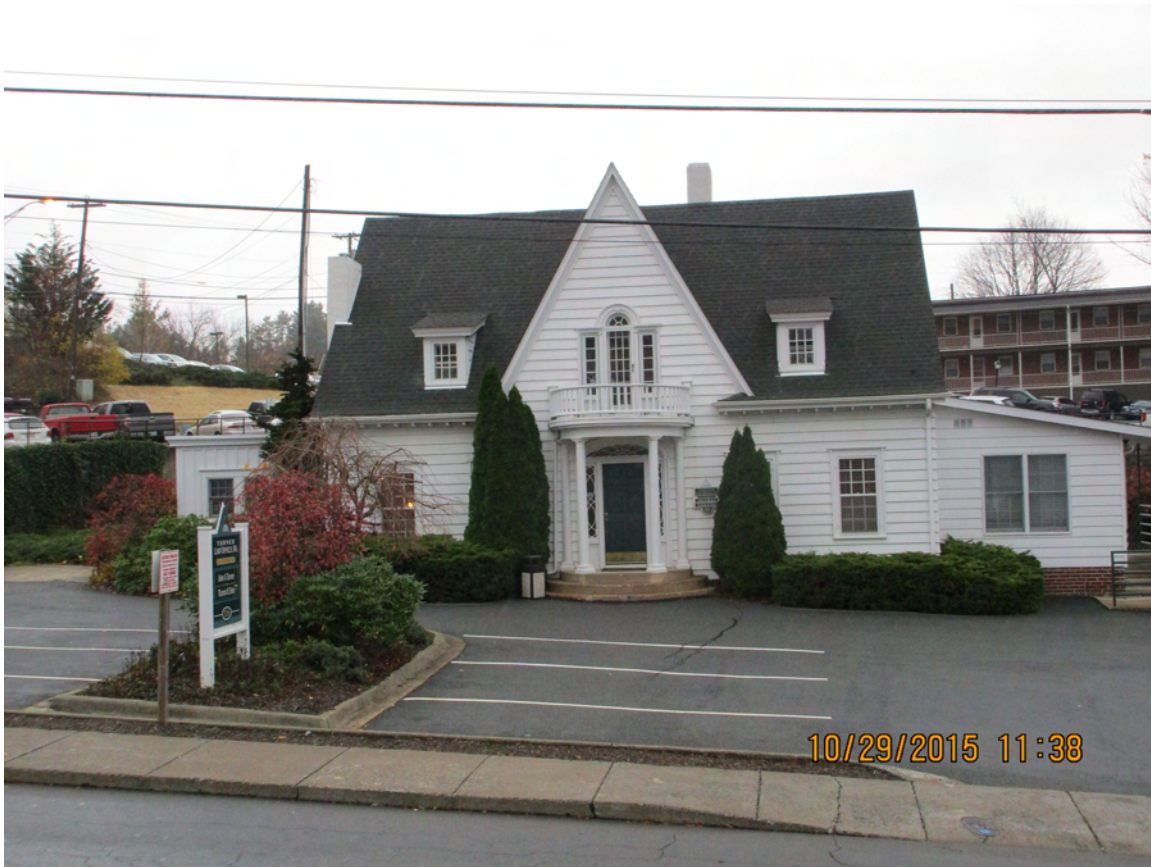
The Oscar and Suma Hardin House (WT0056) as it appeared in October 2015. Image by Nicole Holladay.

Two other significant residences went up on the west end of town during this same period. The Oscar and Suma Hardin House (WT0056, 1926) was somewhat high style for Boone in its design. Located on the east side of North Water Street a short distance from King Street, the one and a half-story, Colonial Revival, frame building offered numerous luxurious, architectural flourishes, including a steeply pitched gable on the main (west) entrance; an ornate, second-floor, Palladian window under the entrance gable; a front entrance with a webbed transom window and full-length sidelights with ornate tracery; and four Tuscan columns supporting the semi-circular balcony porch over the entrance.⁶⁴ A similarly luxurious, new home was the R. L. Clay House (WT0530, 1933), built on the opposite side of the railroad wye at the southwest end of town, near the intersection of Water Street and what is today known as Rivers Street. A one and a half-story, side-gabled, natural cut stone home

Negotiations are currently underway between the Town of Boone and the Watauga County Commissioners in an attempt to preserve the Oscar and Suma Hardin House.

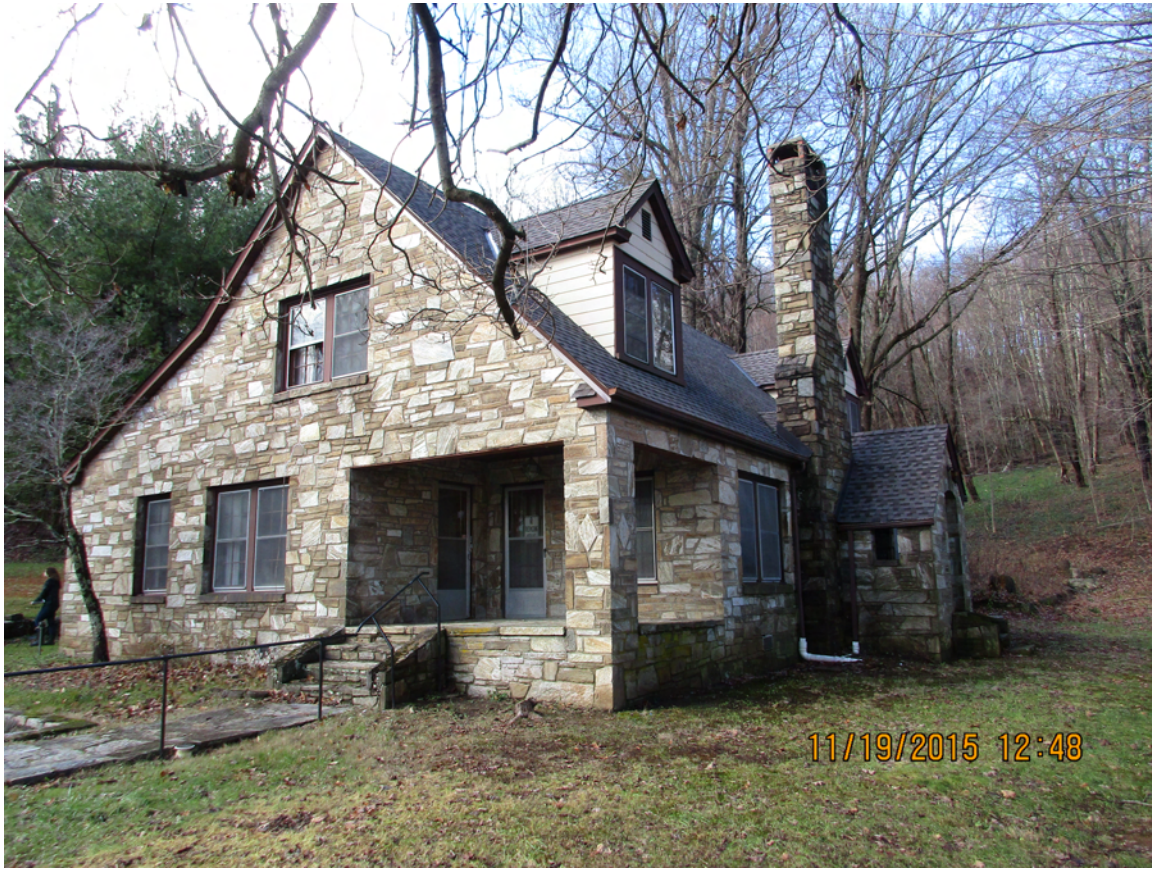
The R. L. Clay House (WT0530) as it appeared in November 2015. Image by Eric Plaag.

with a detached, one and a half-story, natural cut stone garage, the R. L. Clay House is of particular significance because of its association with the workmanship of John L. Hickerson (circa 1889-1938), a local, black brick and stone mason renowned for his masonry work throughout Boone in the 1920s and 1930s. The Town of Boone currently owns the property, which is being considered for Local Historic Landmark designation.

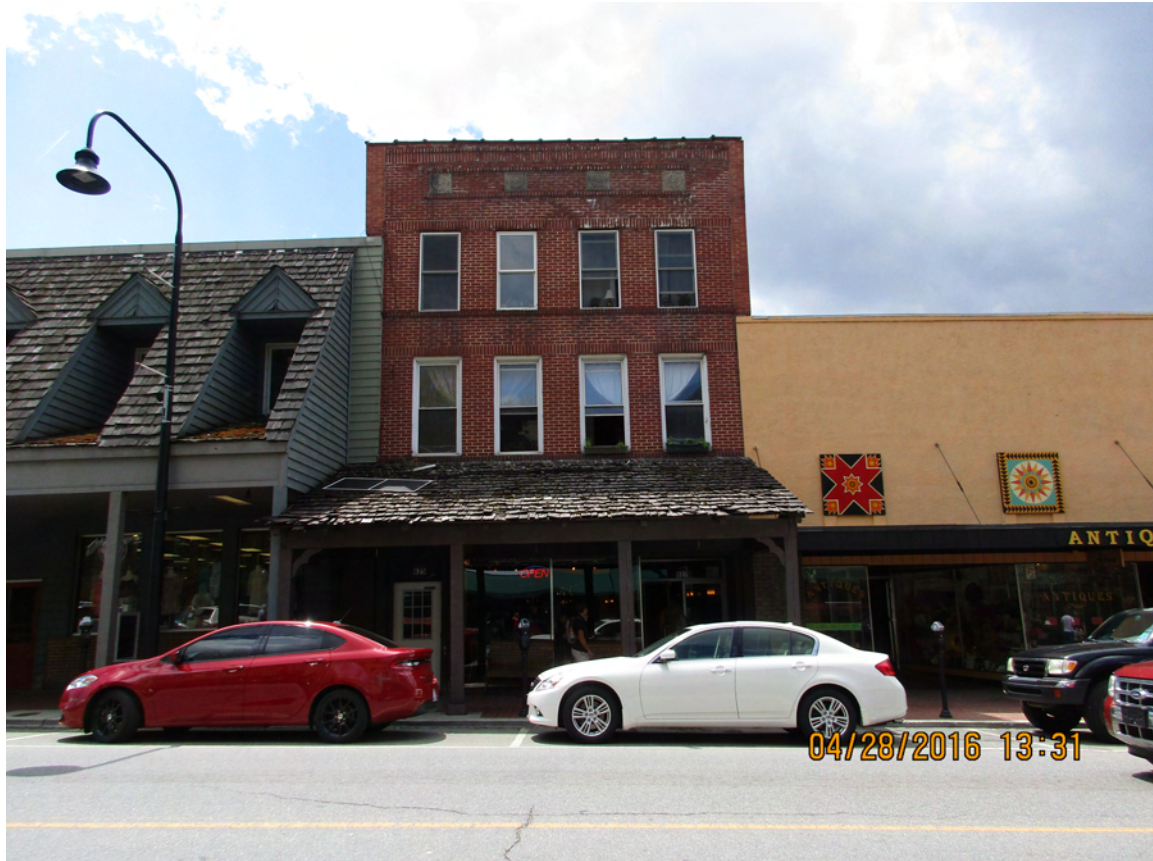
The Hamby and Winkler Building (WT0592) as it appeared in 2016. Image by Paul Fuller.

sophistication—a wood and plate glass store front with inverted entrance, soldier courses serving as a spanning lintel, corbel bands, and frieze panels of running bond brick. This building also featured what would become a familiar trope on Winkler-associated buildings: wagon wheel, limestone medallions near the top of the main elevation.

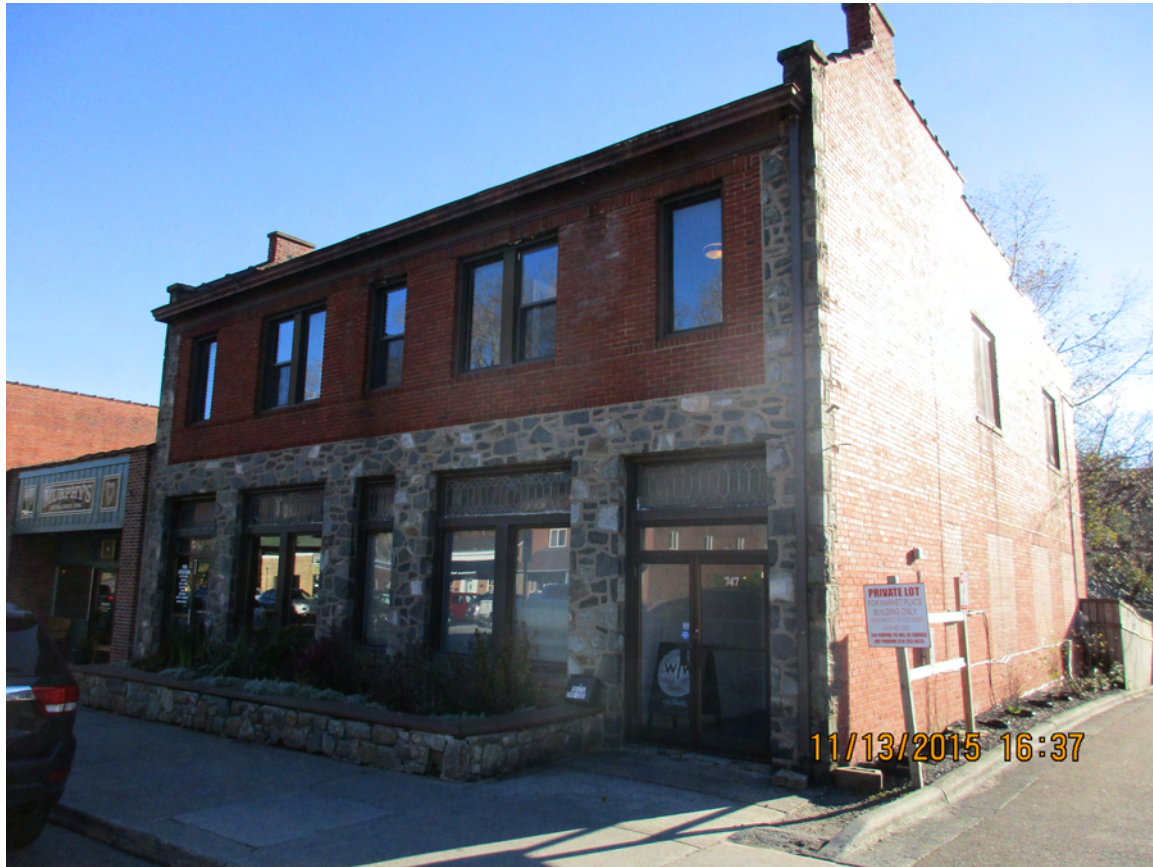
The Rivers Printing Company Building as it appeared in November 2015. Image by Paul Fuller.

Another major addition along King Street in 1937 was the new Rivers Printing Company Building (WT0585), which replaced a brick, one-story building housing the Carolina Store that had been built in 1925 during Boone’s first boom near the site of the original *Watauga Democrat* building. Marking the return to Boone of architect E. A. Poe from Lenoir, the new Rivers building was celebrated for its “distinctive type of architecture” and was constructed by B. G. Teams.⁷¹ The new quarters featured a style that evoked Georgian Revival, even as it subverted some of its traditional forms. This was perhaps most obvious in its north sloping roof, which was clad in terracotta tile, and its parapeted east and west rooflines with faux, end chimneys, all designed to hide the otherwise pedestrian, rubber roof behind the north elevation’s disguised parapet. The face of the north elevation was composed of an irregularly cut, stone veneer on the first floor, which transitioned to stone

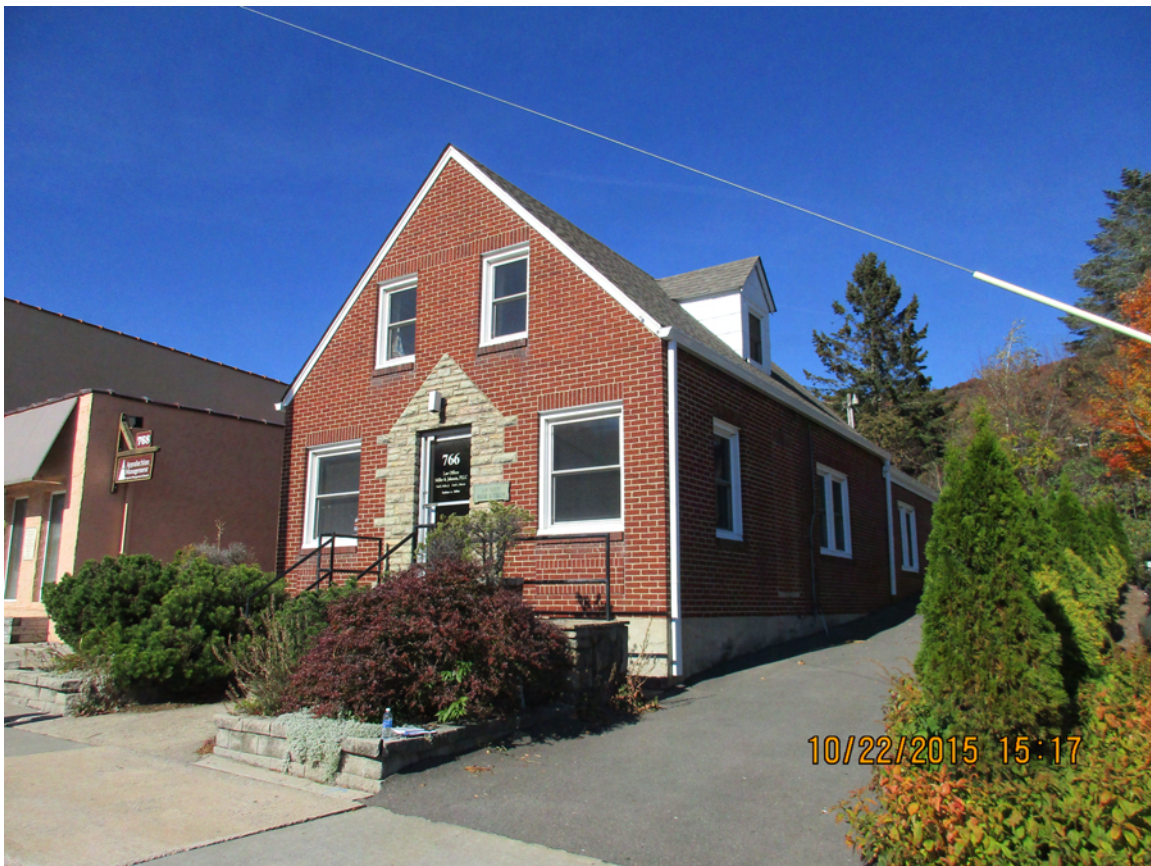
The Wade E. Brown Law Office Building (WT0586) as it appeared in October 2015. Image by Eric Plaag.

Other, less architecturally significant buildings included the narrow, two-story, brick, commercial block B. W. Stallings Jewelry Store (WT0596), built in 1937 immediately east of the proposed Appalachian Theatre lot, and the one-story, brick, commercial block Wilson Building (WT0842) on the other (east) side of the Hahn building, initially built as a grocery store. Also going up on King Street in 1938 were the one-story, brick and native stone, front-gabled, Wade E. Brown Law Office

Building (WT0586) and the one-story, brick, commercial block King Street Grocery Building (WT0881), located at the west end of town, opposite the courthouse. In 1939, E. L. Teague built a new brick structure (WT0807) on the site of his old wooden gas station building at the northeast corner of King and Water Streets. The following year, work began on the one-story, masonry, commercial block Colvard Chevrolet Garage (WT0817) on the east side of North Depot Street.

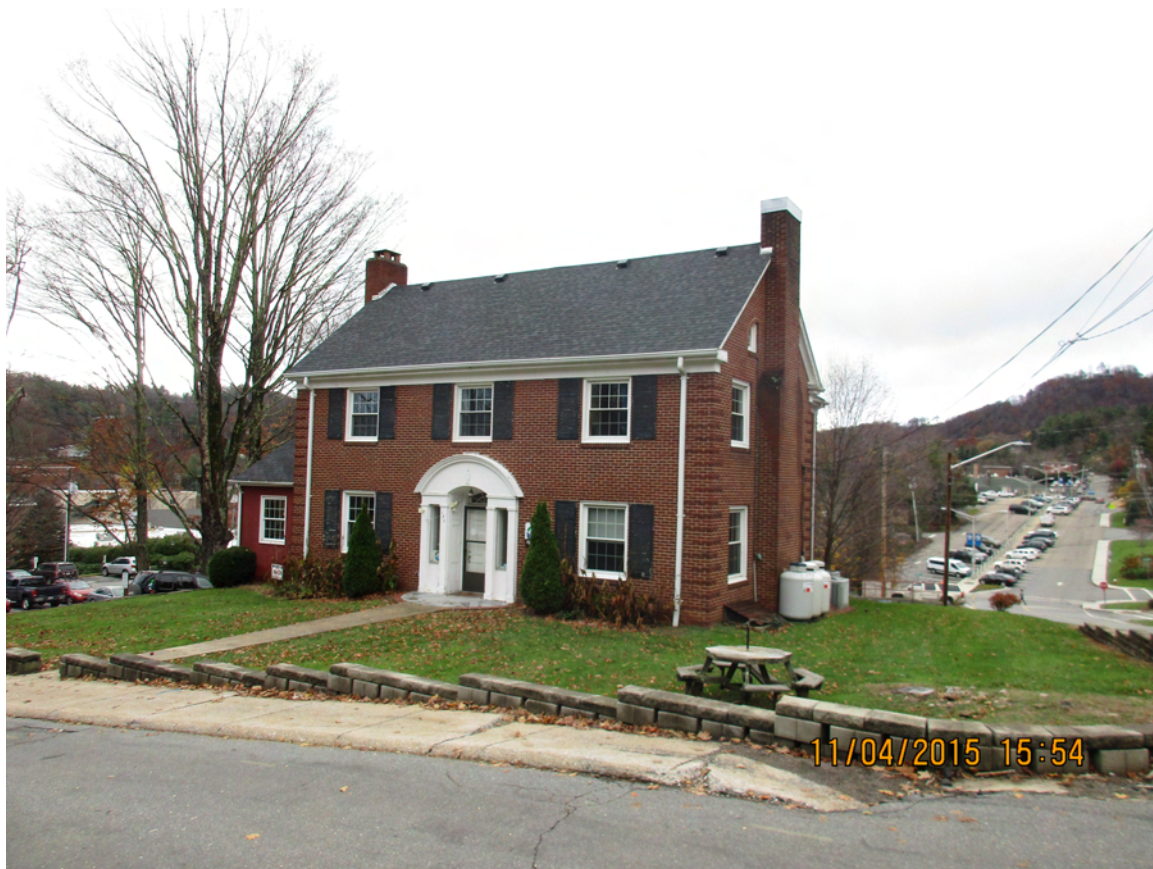
The A. E. and Roberta Hodges House (WT0818) as it appeared in November 2015. Image by Eric Plaag.
