FINAL REPORT (FINAL DRAFT VERSION)

**Comprehensive Architectural Survey of
Downtown Boone, North Carolina**

Dr. Eric W. Plaag

December 2019

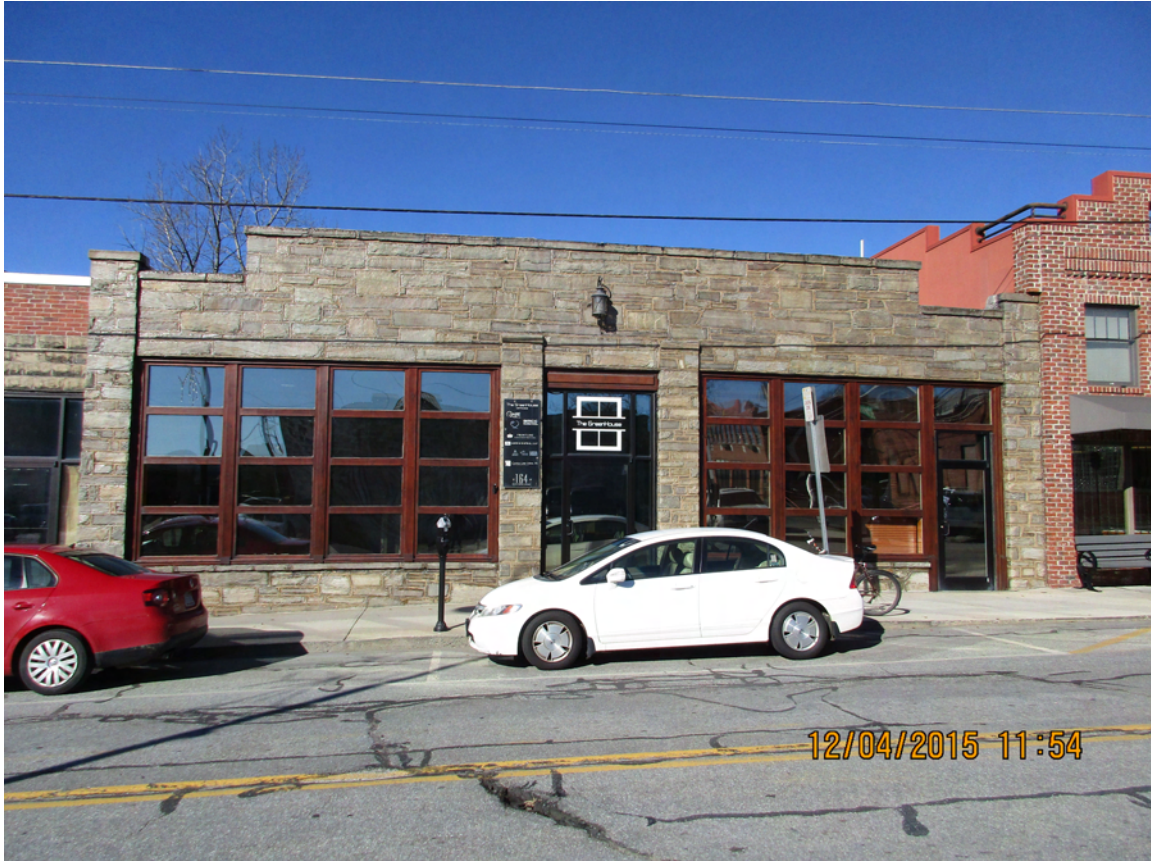
The Duncan Motor Company Building (WT0887) as it appeared in December 2015. Image by Paul Fuller.

While this area between the Linville River Railway depot and King Street already possessed wooden warehouse structures, these new buildings were decidedly more permanent in design. The first of these projects was Brendell's Garage Building #1 (WT0604), a one-story, brick and brick tile, commercial block building located on the north side of Boone Creek near the depot. More architecturally significant buildings included the one-story, native stone automobile dealerships along South Depot Street—the Cook-Nichols Motor Company Building (WT0603) and the Duncan Motor Company Building (WT0887), both completed in 1940.

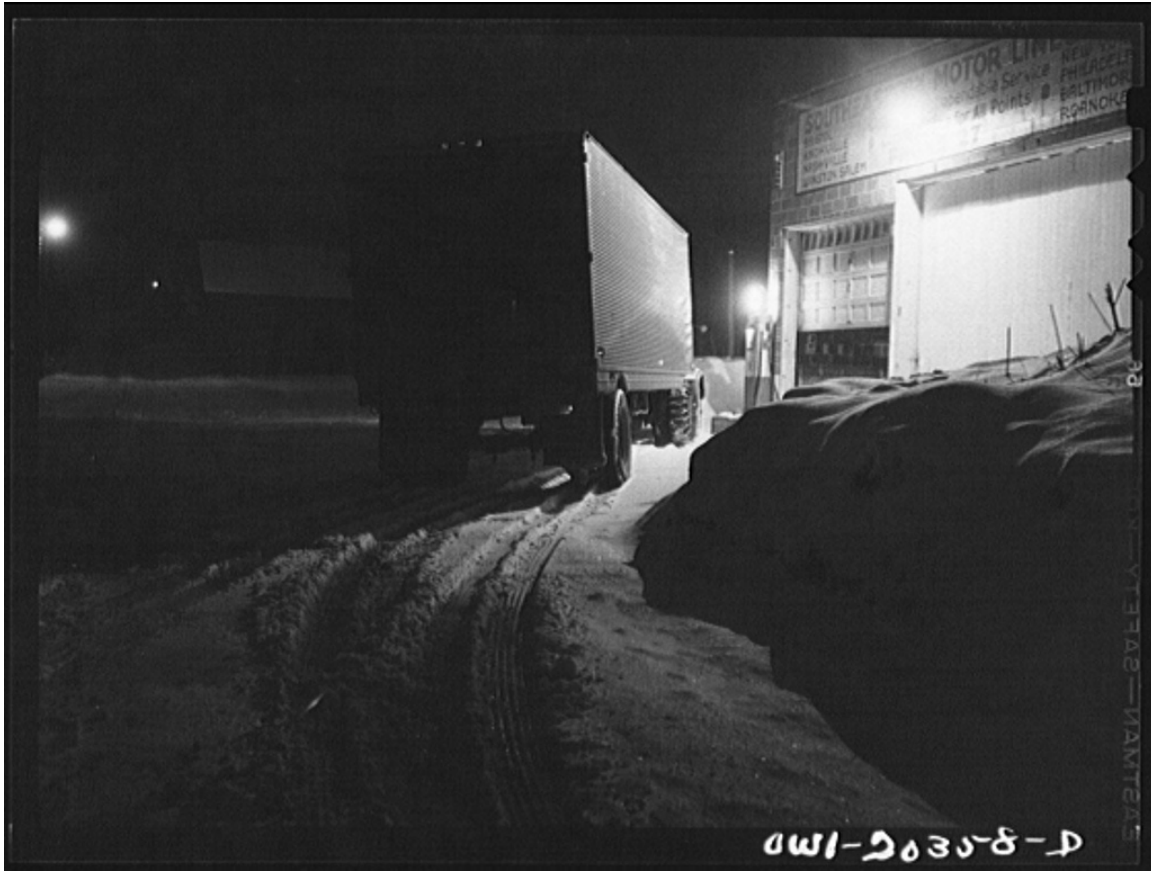
A truck stops to fill up on gas at the new Southeastern Motor Lines building in March 1943. Image by John Vachon and courtesy of the Library of Congress. In the distant shadows is the frame-built Boone Woodworking Company warehouse, later demolished for the Wilcox Drug Company warehouse. The image is indicative of how sparsely developed the Howard Street corridor was before 1944.

The following year, Southeastern Motor Lines built a two-story, concrete block terminal building (WT0868) on the north side of Howard Street about halfway between Depot and Water Streets. To the west of the depot, meanwhile, W. H. Gragg and the Watauga Building and Loan built a frame construction, short-lived, tobacco prize room in 1939 for the Austin Tobacco Company (WT0877); shortly after its closure in 1940, the building was used for decades as an insecticide warehouse. Because of its proximity to the Linville River Railway tracks, it has been misidentified for decades as a part of the original depot building or a railroad maintenance shed.

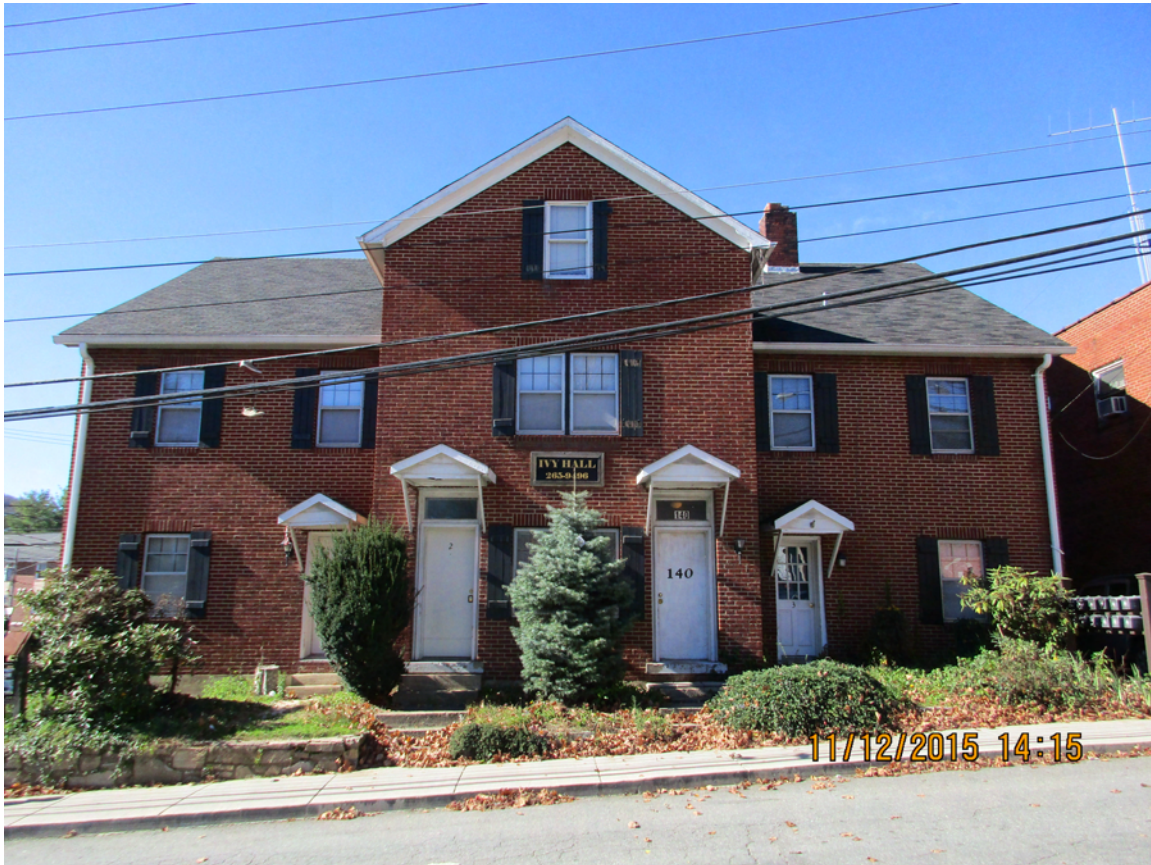
The Dr. H. B. Perry Building (WT0844) as it appeared in November 2015. Image by Eric Plaag.

improving, heavy trucks still struggled to bring in essential construction materials until the heavy emphasis on county road improvements that occurred after the war. The significance of the end of rail service is perhaps most evident in the number of new, downtown buildings constructed in 1940 (nine) and 1941 (three). Of the three 1941 buildings, two (Smithey's, WT0584, and the Southeastern Motor Lines terminal, WT0868) were completed in early 1941, with most of the materials on site by August 1940. The third, the Qualls Library Building (WT0848), has an uncertain completion date that may have been as early as Fall 1940. Indeed, the Dr. H. B. Perry Building (WT0844) is the only downtown Boone building known with certainty to have been completed between April 1941 and 1944.

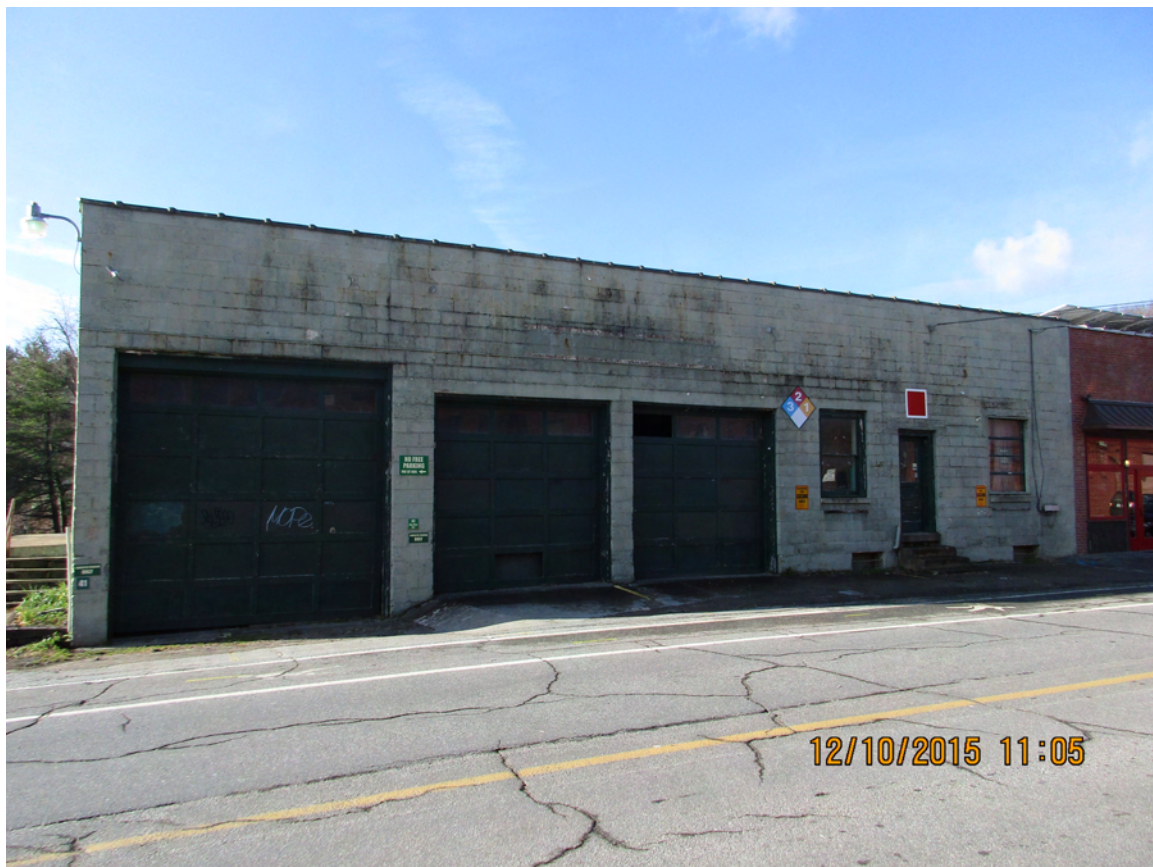
The original, west portion of the Goodnight Brothers Complex (WT0855) as it appeared in December 2015. Image by Paul Fuller.

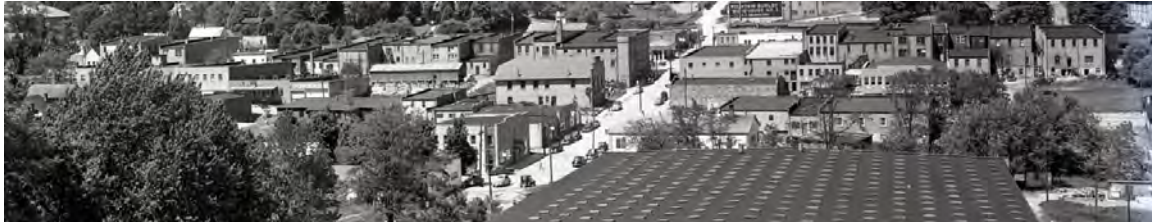
Detail from Pal-Bla-4-104, showing many of the new buildings constructed in the warehouse area along Howard Street between 1944 and 1954, when this photo was taken. Depot Street runs vertically at an angle through the center of the image, and Howard Street runs horizontally across the center of the image, with the backs of King Street buildings at the top and the roof of the Burley Tobacco Warehouse fronting on Rivers Street at bottom right. Image courtesy of the Palmer Blair Collection, Digital Watauga Project.

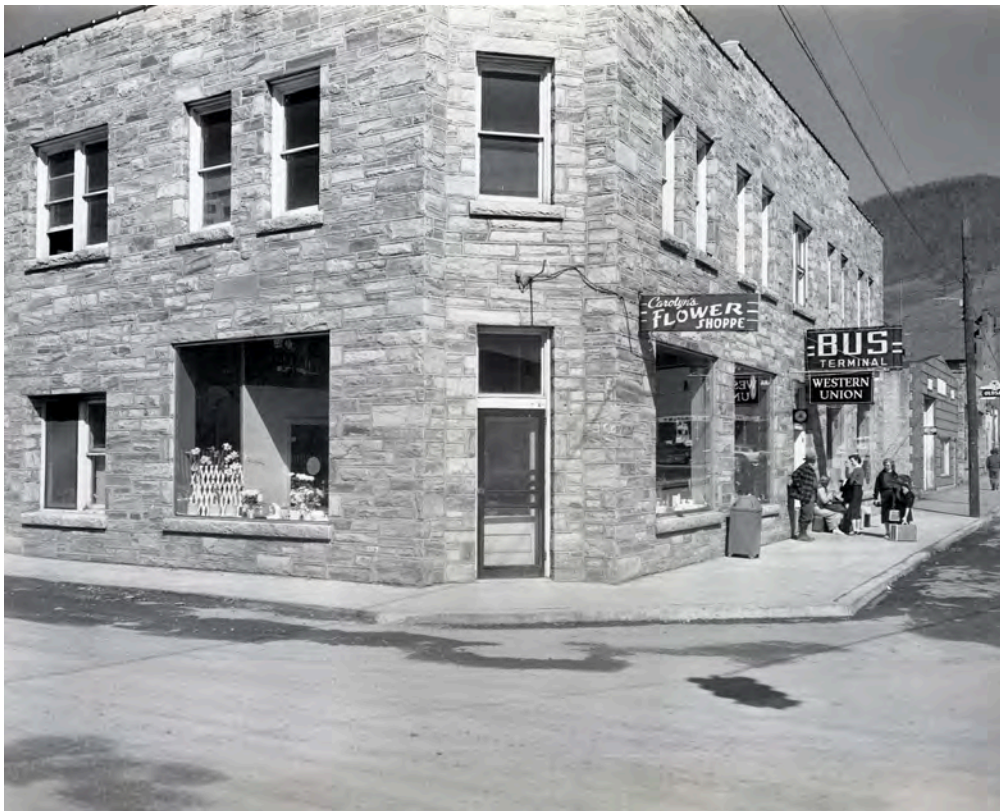
The Boone Bus Depot (WT0612, demolished) as it appeared in February 1955. Image by Palmer Blair, courtesy of the Palmer Blair Collection, Digital Watauga Project.

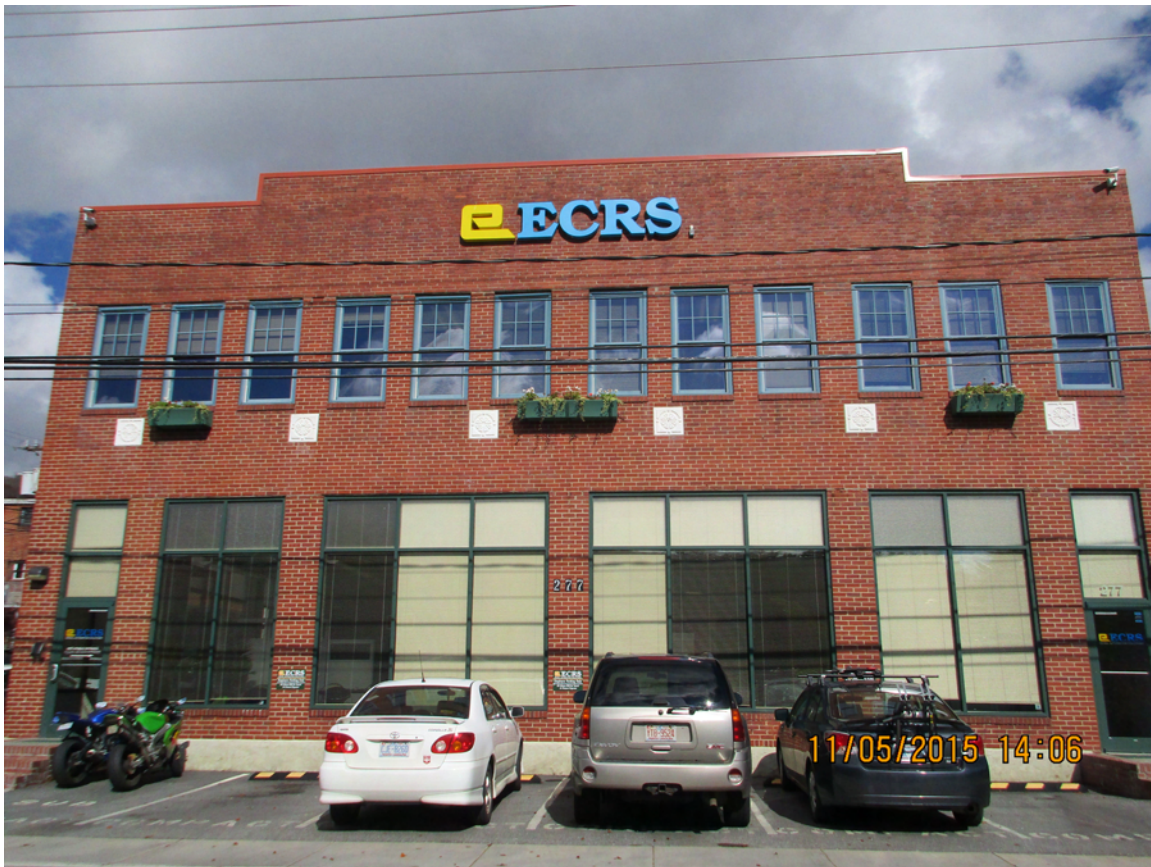
Winkler Motor Company Building #1 (WT0600) as it appeared in November 2015. Image by Nicole Holladay.

bit further to the west along Howard Street J. R. Brendell erected a larger, concrete block, garage building and relocated his Brendell's Garage operation (WT0875). Meanwhile, on the east end of Howard Street, W. R. Winkler continued to expand his auto dealership empire, erecting the impressive Winkler Motor Company Building #1 (WT0600), which was unusually massive for Boone and featured Winkler's trademark wagon wheel medallions. With over 12,000 square feet of floor space and a ramp providing access to a second floor automobile storage area, Winkler used the building primarily as his showroom. About this same time, R. T. Greer started work on the two-story, brick R. T. Greer Building (WT0852) located at the rear of the Crest Store (WT0851) and fronting on Depot Street.

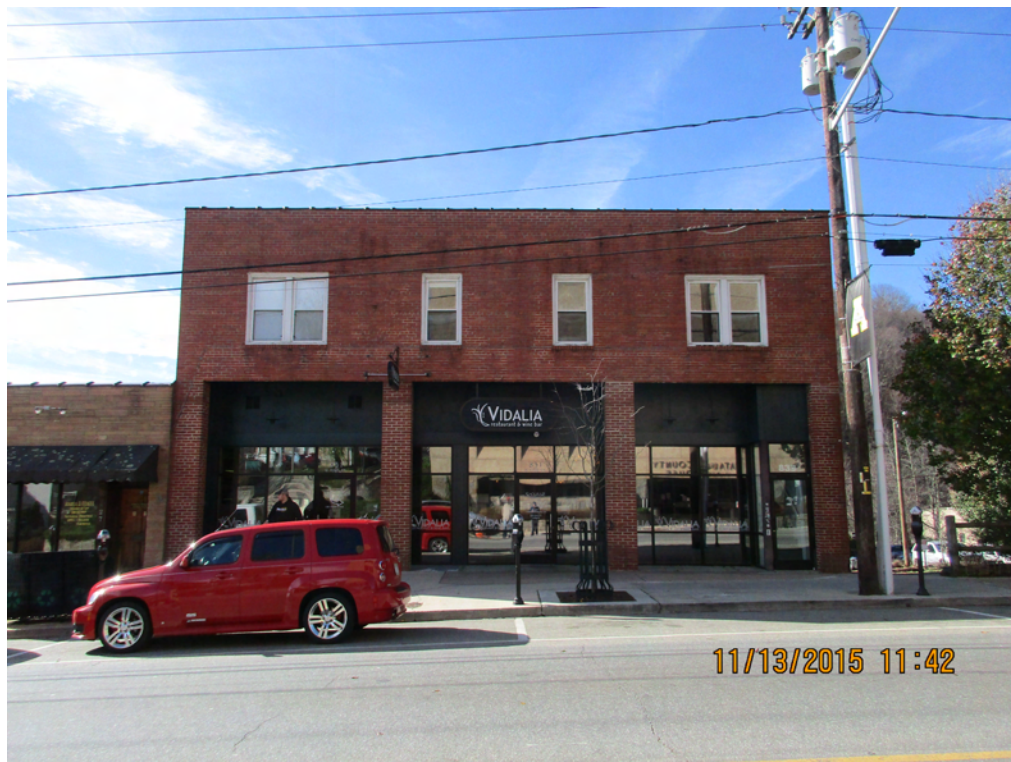
The Edmisten Building (WT0883) as it appeared in November 2015. Image by Eric Plaag.

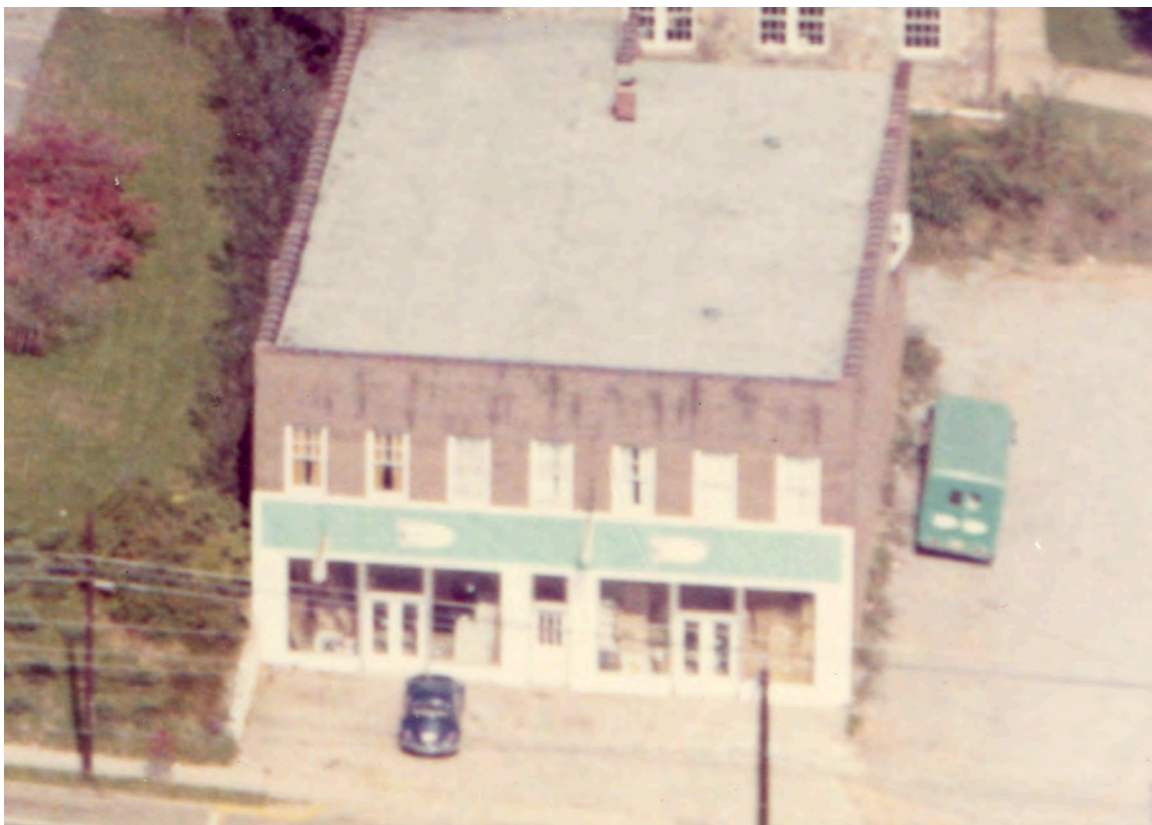
The W. R. Winkler Warehouse and Masonic Hall (WT0806) as it appeared in 1972. Detail crop from Hen-Dew-5, Henry DeWolf Aerial Surveys of Watauga County, Digital Watauga Project.

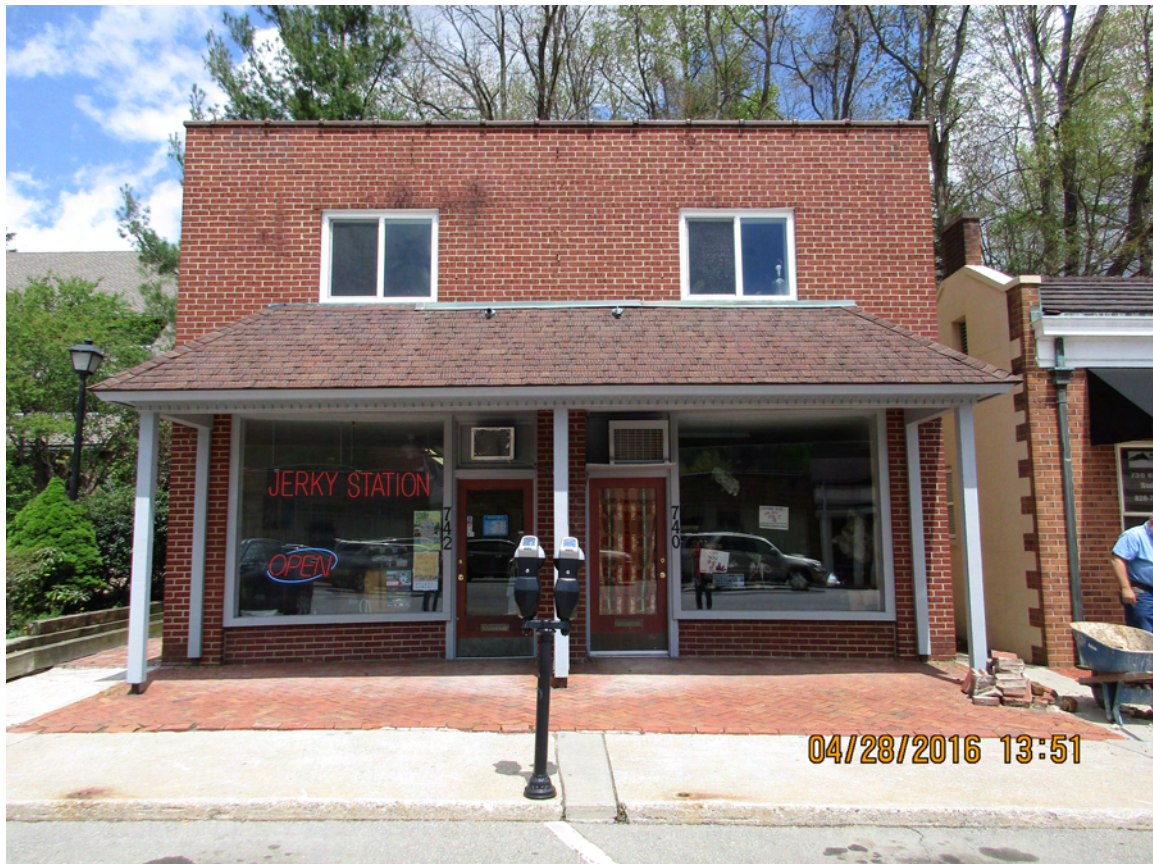
The William Burton Hodges and Ola Wilcox Hodges Building (WT0811) as it appeared in April 2016. Image by Eric Plaag.

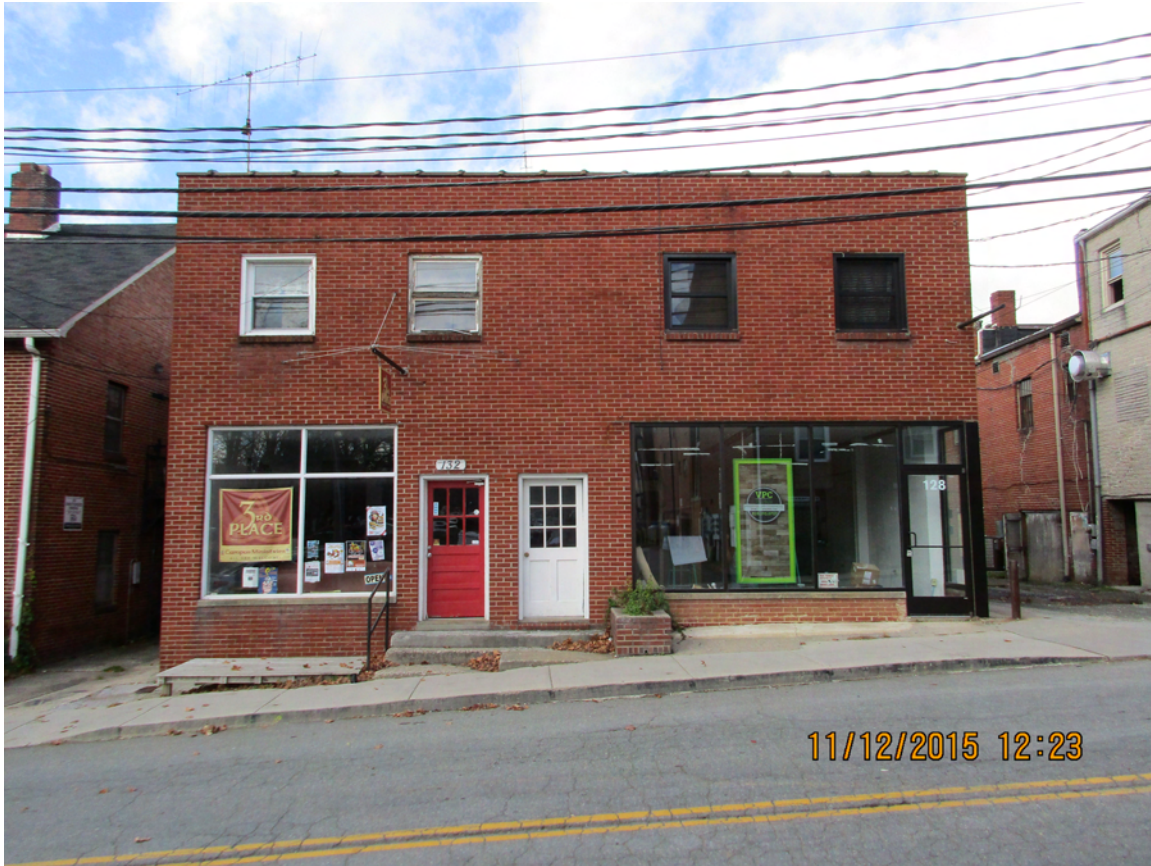
The Anderson-Weston Building (WT0843) as it appeared in November 2015. Image by Eric Plaag.

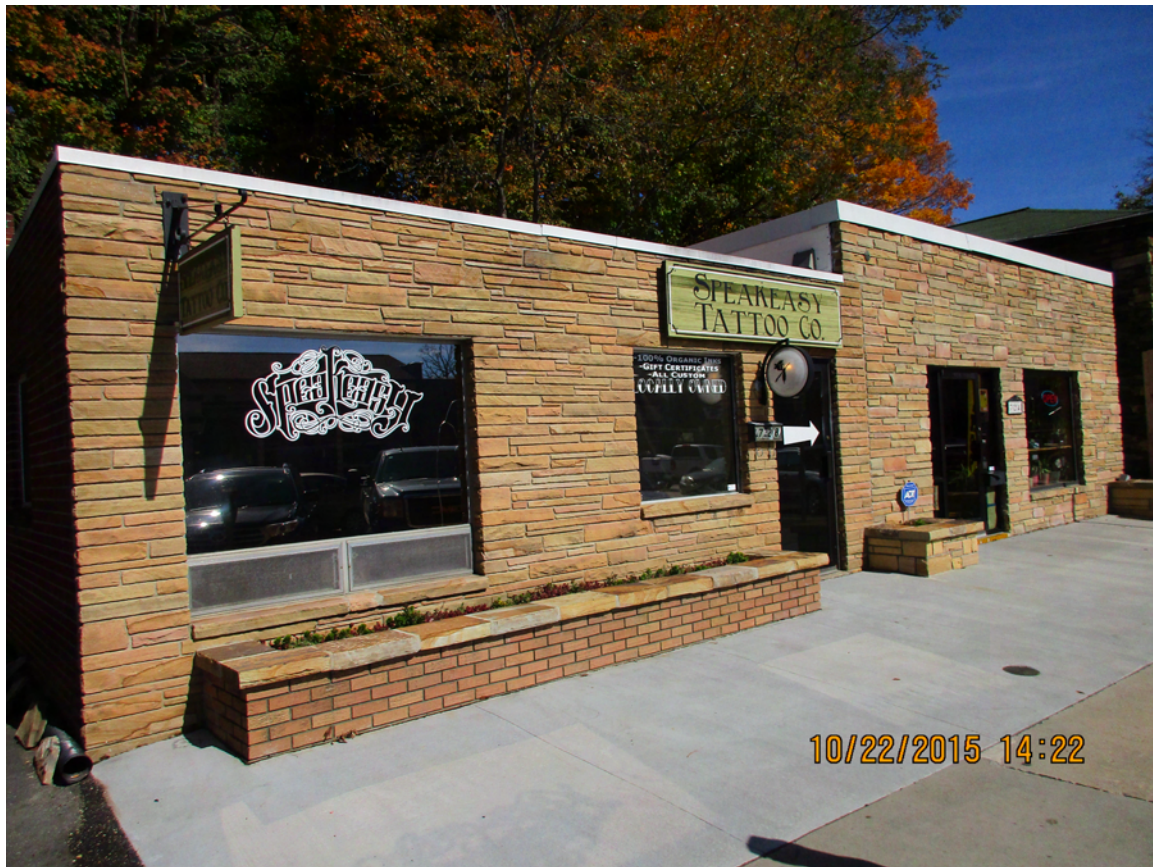
The Stacy Eggers Law Office (WT0813) as it appeared in October 2015. Image by Carson Hamilton.

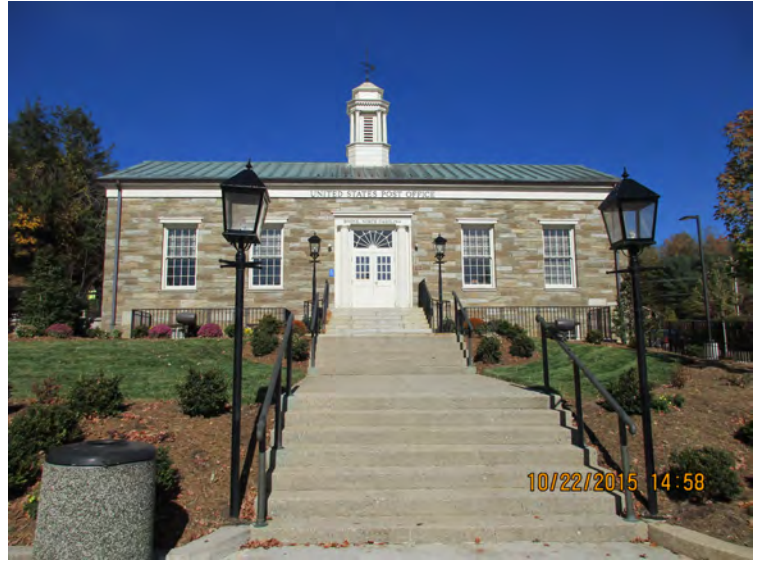
WT0049_Boone_BoonePostOffice_10-15_ep-04.JPG

Located on a rectangular lot that spans the full block between West King Street and Queen Street to the north, the Boone Post Office is situated on a low bluff above West King Street and is reached via a three-flight series of steps that rise from West King Street to the main south elevation. The main block of the side-gabled building is five bays wide and two bays deep and composed of dressed, ashlar stone that rests on a concrete foundation within which is a finished basement presently used for Town offices. The first two flights of steps are of concrete flanked by simple metal handrails, while the third flight of steps at the building façade is composed of cut granite flanked by Adams-inspired, wrought iron balustrades with terminating sweeps that encircle the large metal lamps on each end. The main entry, which occupies the central bay, has been meticulously restored to resemble its original appearance. Single Doric pilasters with a square base flank each side of the entry and support a three-tier entablature consisting of a frieze with the letters spelling out “Boone, North Carolina,” a dentiled corona, and a simple cornice. The double door entry features nine-light wooden doors that mimic the originals, with a gorgeous, rectangular fanlight with spider web tracery over the doors. Symmetrically spaced, slightly recessed pairs of twelve-over-twelve, double hung sash, wooden windows with wooden sills and architraves sit on either side of the main south entry, each window opening in turn supported by a deep limestone sill. The entablature of the main entry is repeated at the south elevation roofline, with the words “United States Post Office” visible on the frieze just below the roofline. The standing seam copper roof and gutters have been restored as well. At the center of the roof beam is a dominant, octagonal lantern with paired Tuscan columns supporting a repetition of the entablature above and weatherboarding cladding the surface below the lantern openings, which are filled with louvered vents. Above the entablature of the lantern is a cap clad in chevroned weatherboard and an octagonal dome adorned by an arrow-shaped weathervane. A cornerstone from 1938 is visible at the southwest corner of the south elevation, with flanking pairs of windows similar to but slightly smaller than those on the first floor visible in the window wells that flank either side of the main entry staircase. Iron balustrades surround these window wells.

The west elevation of the building continues to the north of the main block with a large, rectangular service block that spans nearly the full width of the main block with only a slight setback at each end. This service block is three bays deep and five bays wide. The west elevation's first floor contains three symmetrically spaced windows identical to those found elsewhere on the building, with three slightly smaller versions of these windows found at the basement level within the window well. The entablature found on the gable end of the main block continues along the service block portion of the west elevation, creating a collar appearance against the low parapet that rises above the entablature. Coping along this parapet appears to be of concrete slabs.

The north elevation of the service block, meanwhile, is five bays wide and contains a covered, projecting loading dock extension at the middle bay. A large, rectangular, stone boiler stack rises from the west edge of this center bay, terminating in a raised chimney cap supported by stone piers at each corner. Spacing of windows along the south elevation is slightly tighter, with two large windows identical to those elsewhere found at the west edge and two symmetrically positioned, identical windows on the east end. Just to the east of the east grouping of large windows on the north elevation is a small, four-over-four, double-hung sash, wooden window whose upper sash has been replaced by a vent panel. At the center of the north elevation, meanwhile, is a three-light, rectangular transom that sits just above the roofline of the loading dock roof. This loading dock roof is supported at its northeast corner by a stone column and its west side by a large, stone wall with a narrow window visible at the southeast junction of the loading dock with the service block. This narrow window provides natural light to a boxed-out entry vestibule on the loading dock, which is accessed via double wooden and glass doors on the north face and a single, nine-light, wooden and glass door on the east face of the loading dock. This latter loading dock doorway is reached by a simple concrete stoop with a metal railing. To the east of the loading dock is a staircase descending along the north elevation of the service block to another entry to the service block near the center of the north elevation basement level. The north elevation of the main block, meanwhile, is nearly entirely obscured, aside from a wide dormer with an impressive run of six symmetrically spaced, nine-light, hopper windows controlled by an elaborate, interior, chain-operated mechanism within the service block area (now a conference room).

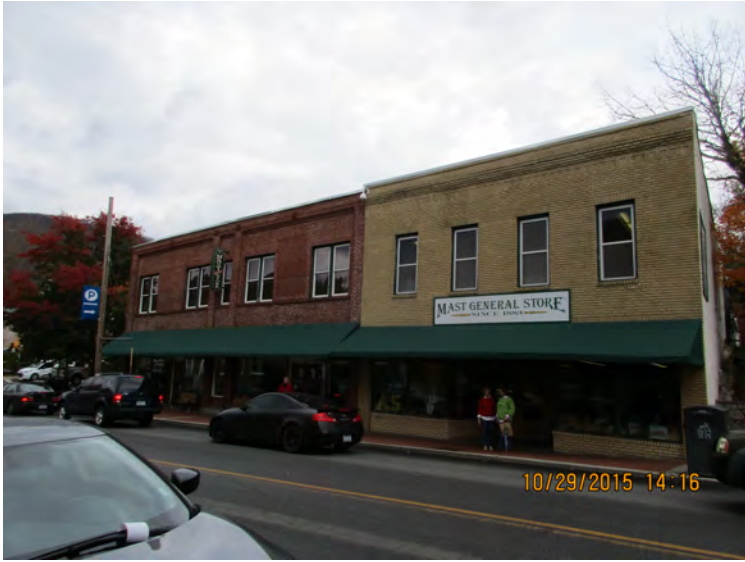
WT0891_Boone_WRWinklerBuilding_10-15_nh-02.JPG

recessed entrance. The clerestory window by this time had been replaced with a divided, clerestory window of clear glass with “Blue Ridge Supply Co. Inc.” painted on this glass. No awning was present. A 1958 Homecoming Parade image in the Appalachian Digital Collection shows this same basic configuration in place. Beyond the first recessed entry to the east was the off-center, middle shop window at the façade plane, with flanking shop windows angling toward the two recessed entrances. Beyond the west recessed entrance was a single, plate glass window in an aluminum frame at the façade plane. By this point, tenants had mounted a fabric, retractable awning over the divided, clerestory windows. This awning was replaced between 1958 and 1963 (His-Boo-1.43.5) by a cable-hung, flat awning similar to those mounted on WT0591 a few years earlier. Mast General Store removed this awning sometime prior to the 2002 survey. Curiously, the original storefront configuration of the building, with its two single-entry, recessed entrances with narrow transoms and angled shop windows, remained intact until sometime after the 2002 survey, when Mast completely reconfigured the storefront of WT0891 to its present appearance.

by plate glass, shop windows that angle back toward the façade plane. Two large, plate glass windows in metal frames are present on both sides of the recessed entrance at the façade plane. The entire shop window configuration features new bulkheads of yellow brick that is slightly off color from the original yellow brick of the façade. A vinyl awning on a metal frame now spans the entire storefront, underneath of which is a spanning, clerestory window similar to the second iteration of this feature on the building, although the glass seems to have been replaced.

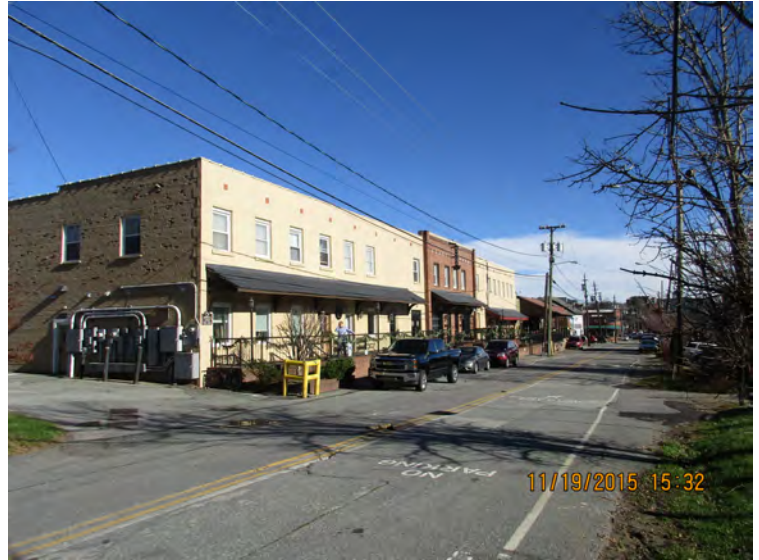
WT0892_Boone_BooneTireAndBargainStoreWarehouse_11-15_nh-01.JPG

designed to make the division among the three buildings appear to be symmetrical. Coping is of metal rather than terracotta. The shingles of the shed-style awning on WT0892 are wood rather than terracotta, and the awning features a decorative, sawtooth fascia board not found on the other awnings of WT0602. It appears that a window at the west edge of this building's first floor on the south elevation has been filled in and parged over. To the east of this is a one-over-one, double-hung sash, vinyl replacement window, to the east of which is a large, sixteen-light, vinyl replacement window like that found on the west building of WT0602. A double-door entrance at the center of the first floor of this elevation consists of wood doors with fifteen lights and a single-light transom. Another one-over-one, double-hung sash, vinyl replacement window completes the first floor of the south elevation of WT0892. The second floor offers six symmetrically spaced, two-over-two, double-hung sash, vinyl replacement windows with faux muntins, each of which is ill-fitted to the original piercing. Five evenly spaced, dogtooth medallions are visible above the second floor windows. As on the other buildings of WT0602, a brick retaining wall supports a narrow porch area on the first floor, which is of wood. Iron balustrades run the length of the porch, while a staircase at the west end rises to the porch in front of the east building of WT0602.

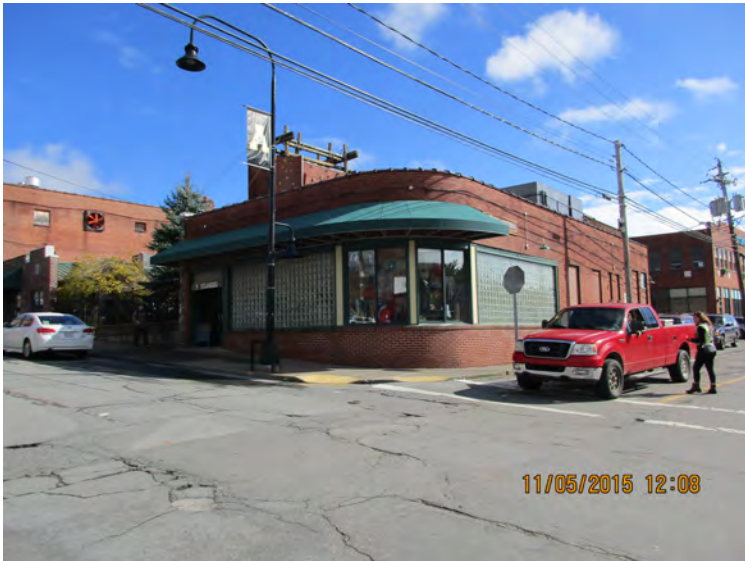
WT0893_Boone_WinklerMotorCompanyShowroom_11-15_nh-06.JPG

Past surveys have grouped this building with two other buildings under WT0603 and described the complex as having been built in the late 1930s, which recent research demonstrates is too early. Those surveys have also ignored the vast complexity of the ownership and use history of these properties. As noted in the 1988 survey, the complex essentially consisted of three buildings. The northernmost portion was something of an afterthought, built after numerous transactions in the early 1940s essentially created a narrow, buildable parcel just north of the middle building, which had been built in 1940. The third building, at the south end of the parcel, came later, in 1950, and unlike the other buildings, was built explicitly for the Winkler Motor Company operations. For this reason, the third building has been separated out as a distinct building under this survey number, WT0893.

The east elevation of the south addition, meanwhile, features a very large, two-story addition clad in board and batten. A large, stepped parapet is visible on the east face of this addition and is coped in metal. Below this is a bay of five vinyl replacement, casement windows on the second floor. The east face of the first floor of this addition offers a large window bay that is covered with diagonally arranged boards. The south face of this unusual addition offers a three-light, casement window bay of vinyl replacement windows on the second floor and a single doorway at the southeast corner. This addition, which appears to rest on a concrete foundation, also overlaps the roof of the original south addition at its west end, and a two-light window configuration—possibly a sliding glass door—is partially visible leading from east addition onto the roof of the south addition. It is not known when this addition was completed, but it obviously postdates the 1996 fire.
